Water Supply pumps Project

Laboratory Testing,
Field Trials
and Technological
Development

Report No. 1
March 1982

UNDP/WORLD BANK - RURAL WATER
SUPPLY HANDPUMPS PROGRAMME

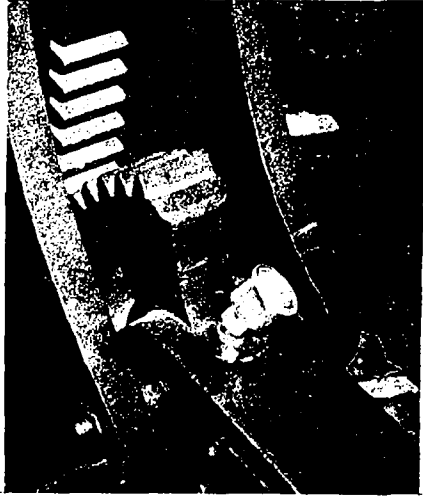
The case containing the pump stands had been damaged and the grease cups on the handles of both pumps were broken

(See photograph, left).

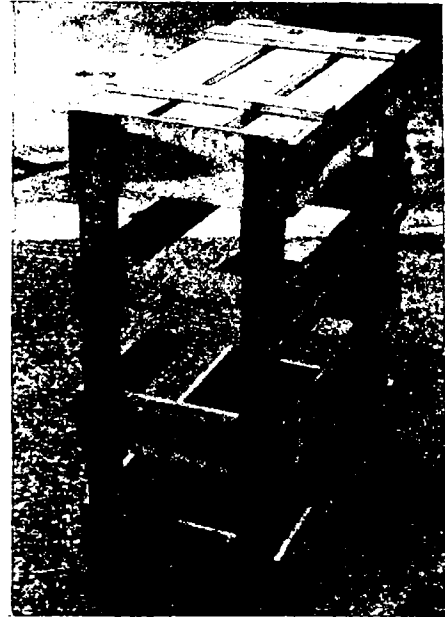
The pumps were not entirely free from damage, however. The spout of one pump stand had rubbed on the packing case, damaging the plastic coating.

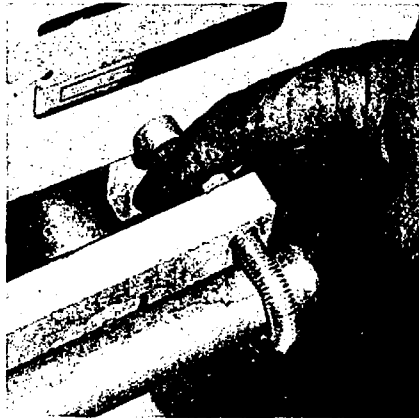
CODE D The handle on this pump is particularly heavy and would be
dangerous if the operating cable were to break in use.
.....

There are a number of potential finger traps between the handle and the pumpstand (left) - increased clearances would help considerably.

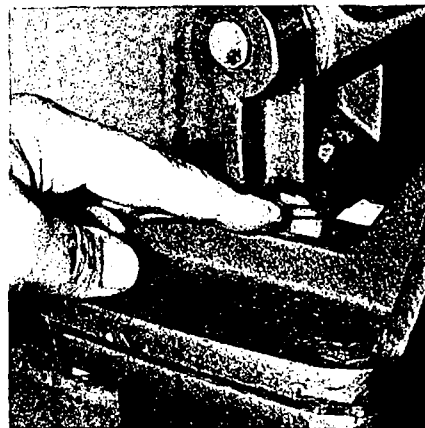
CODE L There is a potential finger trap between the connecting rod fork and the top of the pump stand (right).

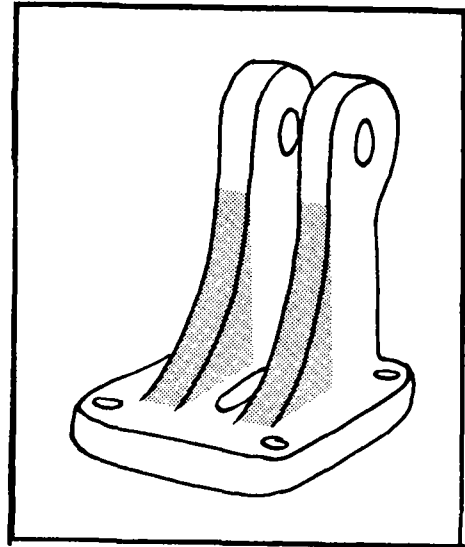
- CODE A
1. The piston valve lift should be reduced (ideally to one quarter of its diameter) and its lateral location improved. Its efficiency may also be improved by providing a leather or rubber valve seat.
 2. The grease cup lubricators are a good idea in principle, but more robust components are needed.
 3. The quadrant and rack present a considerable safety hazard and should be shrouded.

This could be achieved either by modifying the casting patterns for the pumphead side plates (see sketch, right) or by adding simple sheet metal covers.

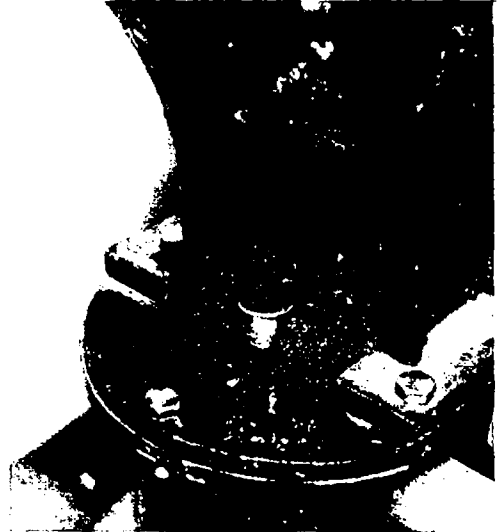
CODE A Considerable wear of both the quadrant and rack, depositing metal swarf on the pump top but no stoppage.

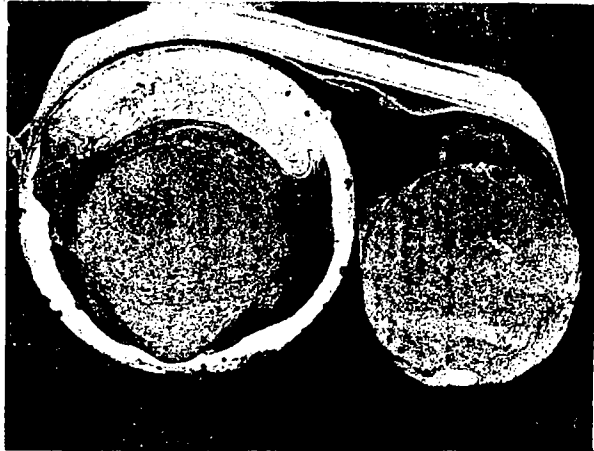
The break appeared to have propagated from a small surface imperfection - either a weld spatter or a spot where the welder had struck his arc, at the top of the photograph (right).

The handle was replaced with that from the second sample pump. The manufacturer later supplied new tubular handles designed in response to similar breakages in the field. A tubular handle was fitted at 751 hours.

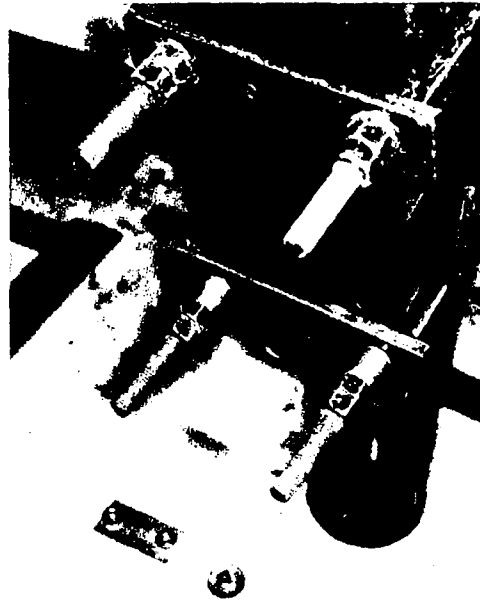
CODE E The U-bolts attaching the wooden fulcrum upright to the rising main have unnecessarily long ends which have not been deburred. (right).

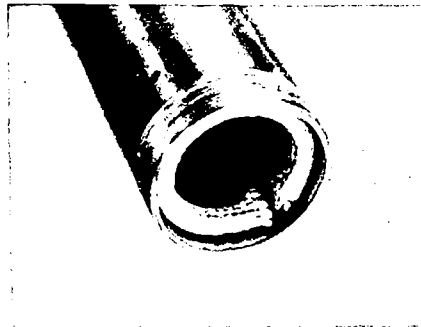
It was clear that the lengths of cord used to make these piston rings were too short. Although a snug fit on the piston, they did not fit the cylinder bore, as the photograph shows (right).
