# STATUS OF THE AID TYPE HANDPUMP IN THE DOMINICAN REPUBLIC

WASH FIELD REPORT NO. 98

AUGUST 1983

Prepared for:  
USAID Mission to the Dominican Republic  
Order of Technical Direction No. 143

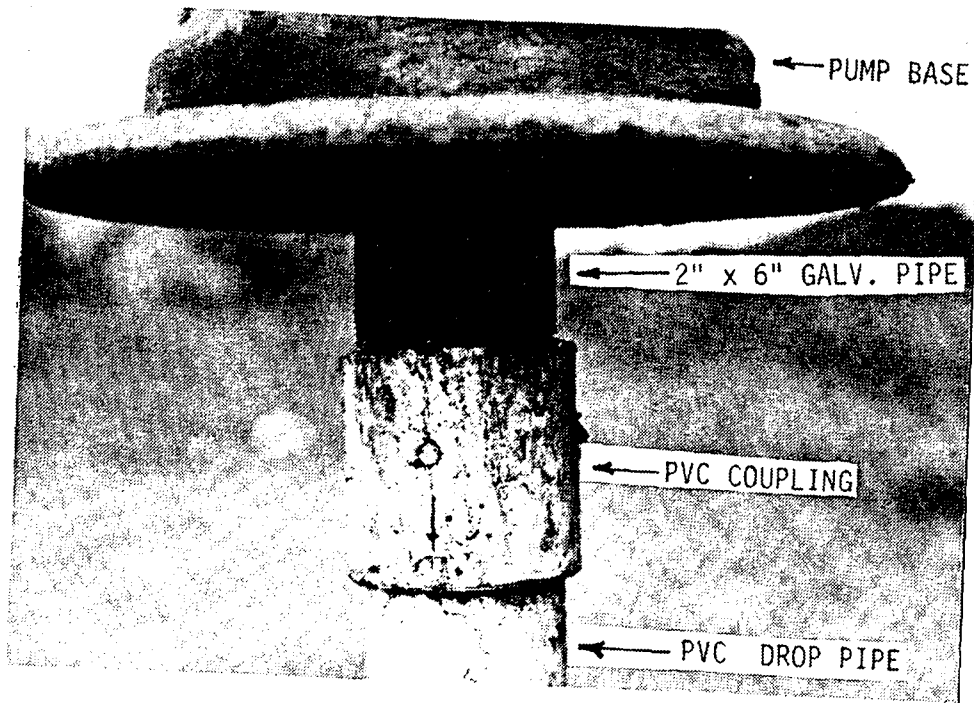
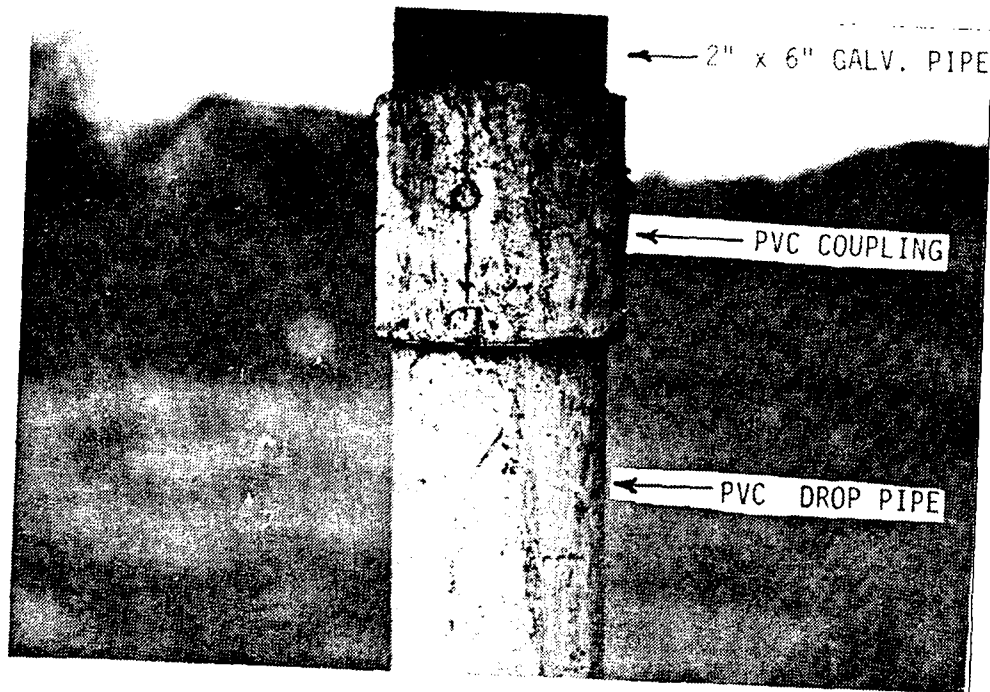
Figure 2  
HAND PUMP BASE AND DROP PIPE  
CONNECTION ASSEMBLY

- o Problem Area 3 (15 percent) - Separation of the PVC occurred at the joint between the drop pipe and the PVC male-threaded adaptor in six cases. When inspected, little, if any, PVC solvent was found sticking to the internal surface of the PVC adaptor (Figure 2). In five cases the drop pipe had to be lifted out of the well by bonding another length of PVC pipe to it. The pipe ends became covered with new solvent in this process, so their surfaces could not be inspected. In one case it was possible to lift the PVC pipe out of the well with a rope. This allowed a better inspection since the pipe surface was not covered by new solvent.

- o To prevent separation of the PVC pipe assembly at the handpump base, SESPAS could continue to use the 2-inch diameter by 12-inch long bell-ended PVC pipe section between the 2-inch PVC coupling and the PVC drop pipe assembly (Figure 3). This seemed to have reduced the frequency of pipe separation at this location. However, field data are not sufficient to guarantee the success of this approach, and it should not be expected to totally correct this problem (i.e. while it can be expected to reduce the number of early drop pipe failures it cannot be expected to eliminate them).

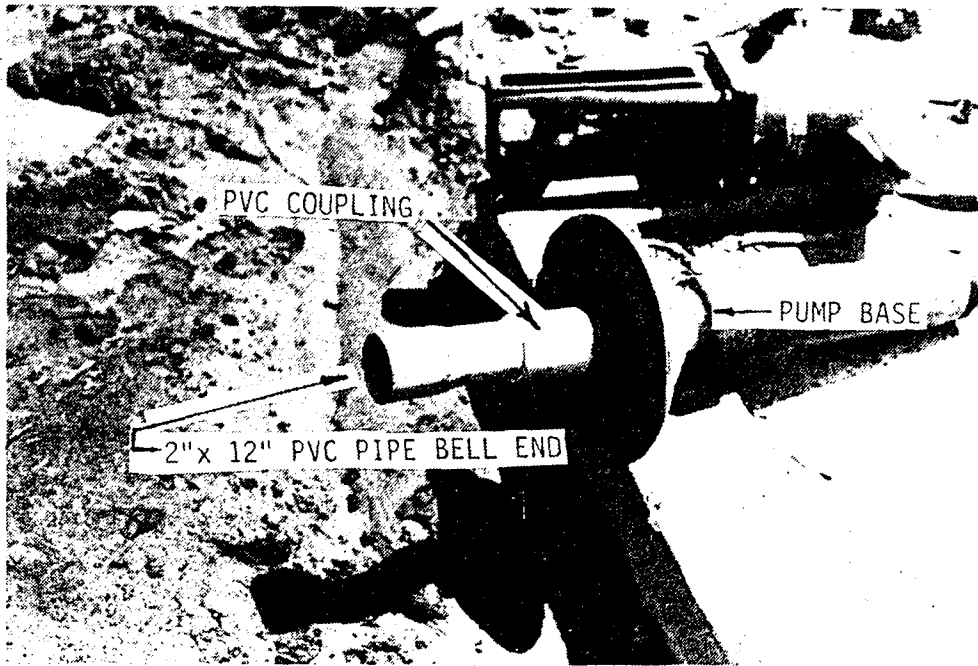
Figure 3

PVC DROP PIPE CONNECTION GLUED 24 HRS. PRIOR PUMP INSTALLATION  
TO PREVENT PVC DROP PIPE SEPARATION

- o The remaining 640 handpumps yet to be manufactured could be of the modified AID design. However, the PVC foot valve should be replaced with a locally available 1.25-inch brass foot valve (a Clayton Mark or equal model which is available in Dominican Republic hardware stores for approximately \$8.00). Implementation of this change would require purchasing the brass foot valve and a 2 by 1.25-inch reducer.
- o To prevent separation of the PVC drop pipe assembly at the handpump base, the SESPAS installation and maintenance crews have used a 2-inch diameter by 12-inch long bell-ended section of PVC pipe between the 2-inch PVC adaptor and the PVC drop pipe assembly (Figure 3). The 2-inch PVC adaptor and the 12-inch section of PVC pipe are glued 24 hours prior to handpump

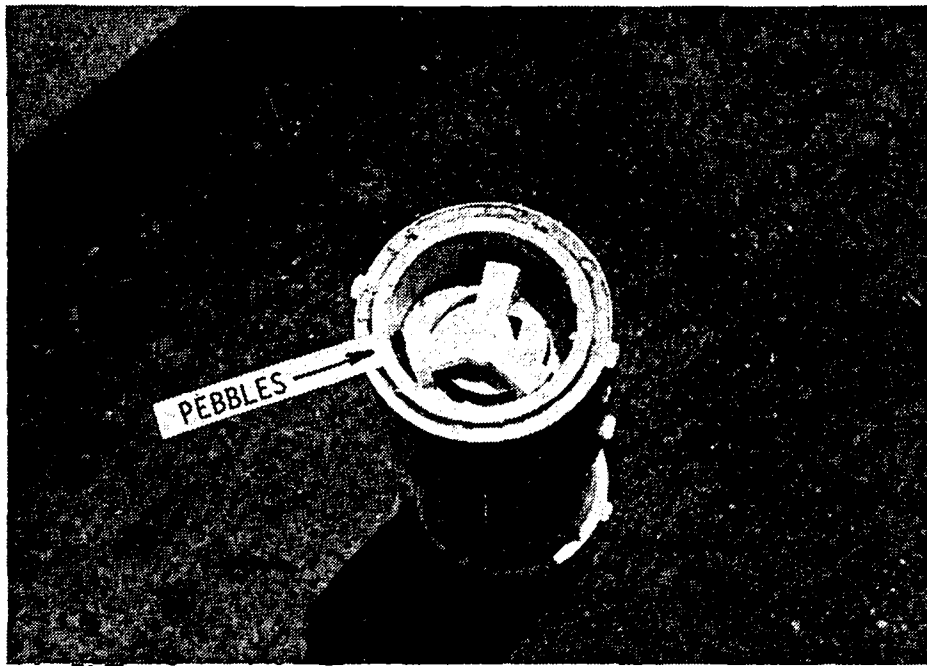
- FOREIGN MATTER -

Pebbles lodged between poppet valve and its seat causing leakage of the water column

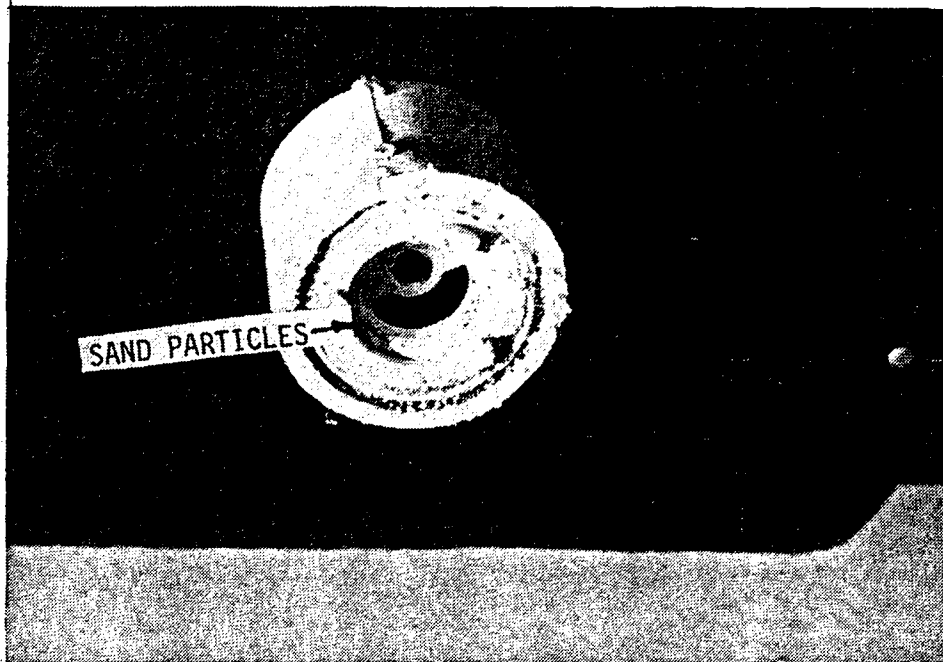
- FOREIGN MATTER -

Sand particles interfering with the proper operation of the PVC foot valve causing leakage of the water column

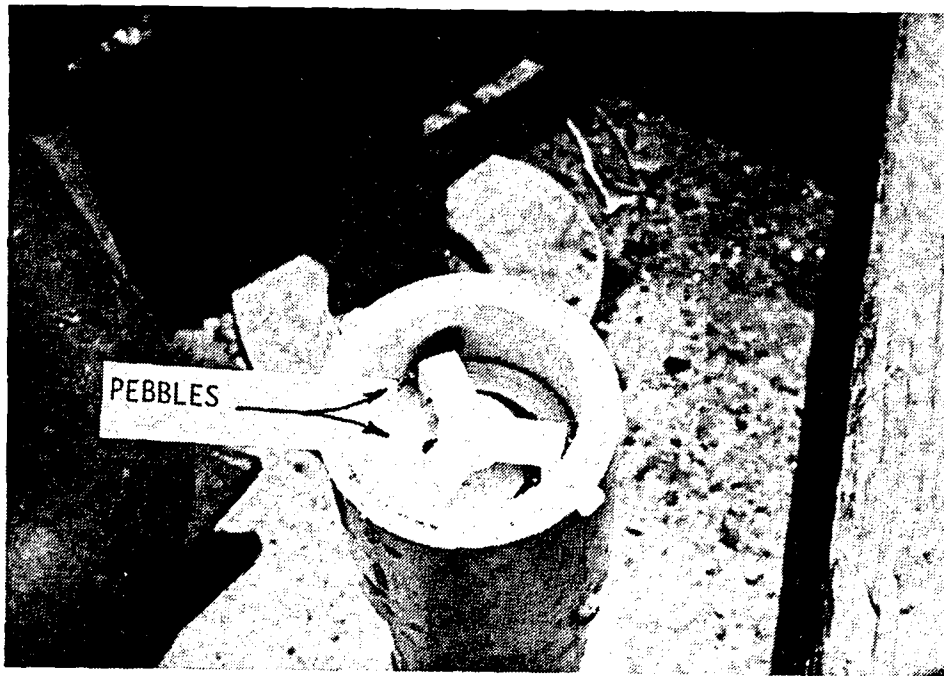
- FOREIGN MATTER -

Pebbles lodged between poppet valve and its seat causing leakage of the water column

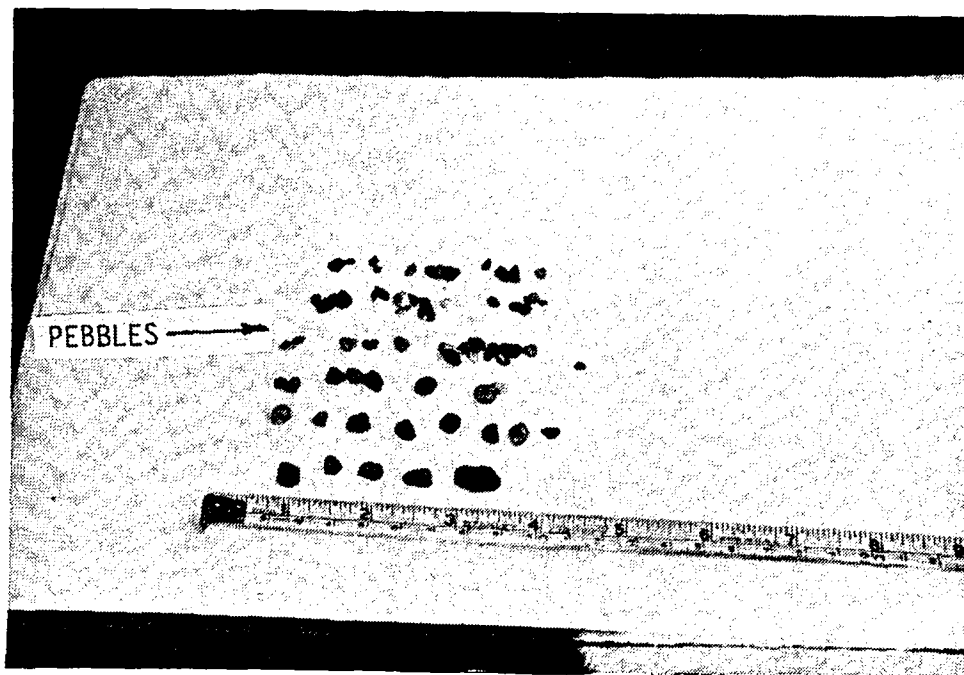
- FOREIGN MATTER -

Pebbles found in a PVC foot valve

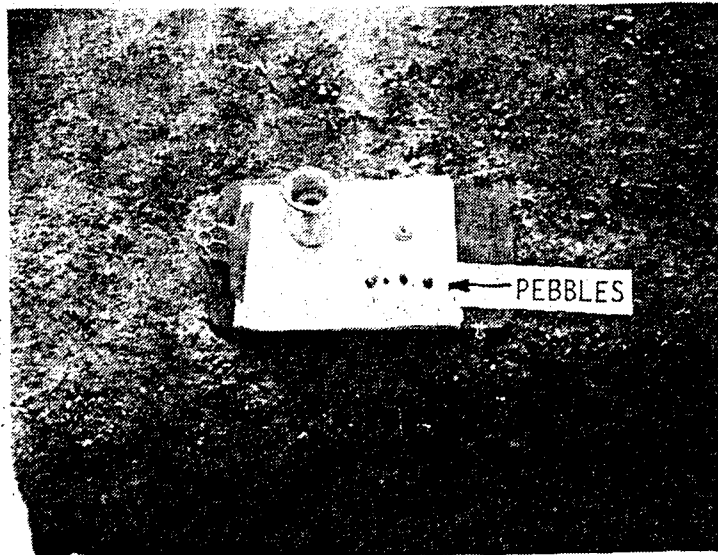
- FOREIGN MATTER -

Pebbles lodged between poppet valve and the seat of this PVC foot valve causing leakage of the water column

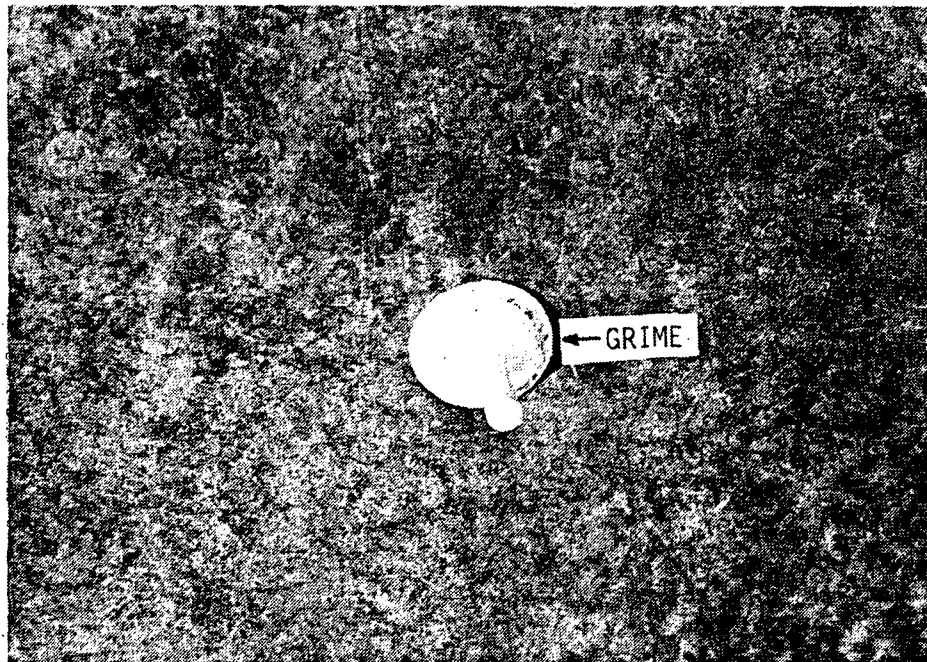
- FOREIGN MATTER -

Grime on the PVC poppet valve seal causing leakage of the column of water

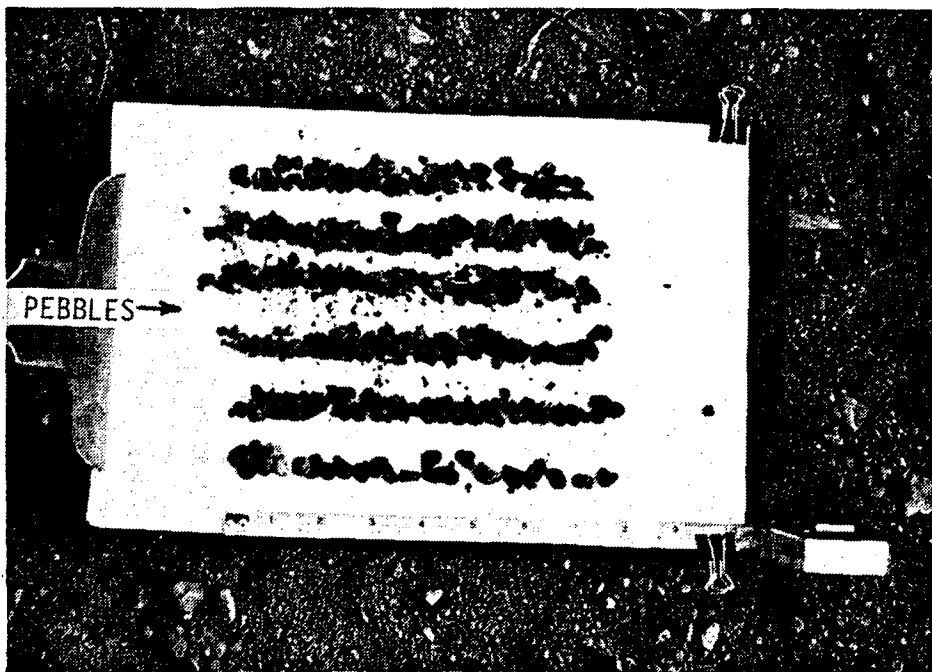
PEBBLES & TWIGS →

- FOREIGN MATTER -  
Pebbles found in the above plunger

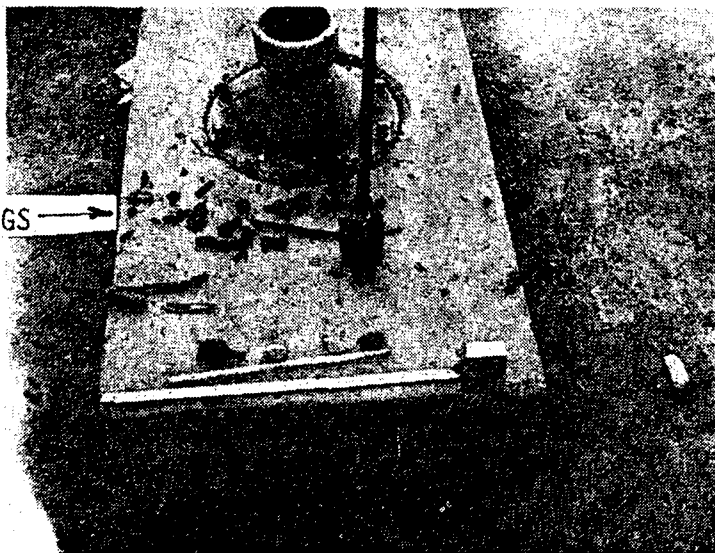
- FOREIGN MATTER -

Pebbles and twigs lodged between poppet valve and its seat causing leakage of the water column

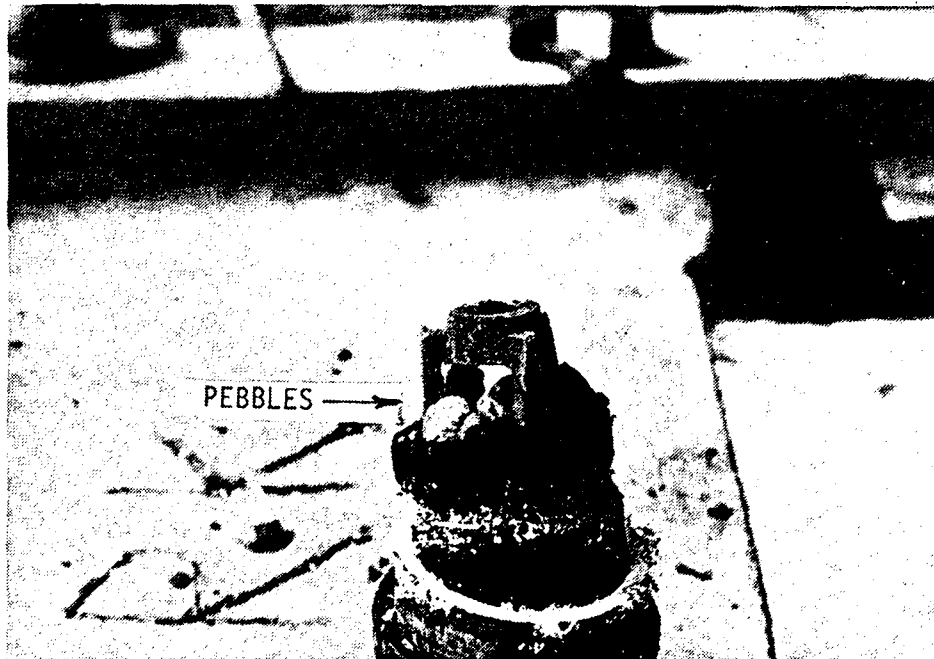
- FOREIGN MATTER -

Closer view of the above plunger

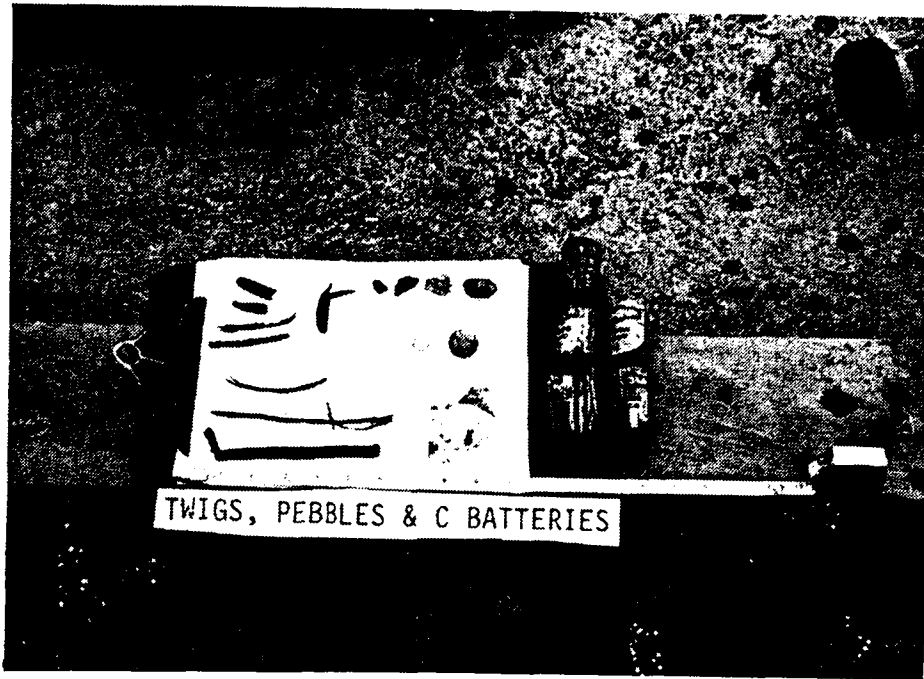
- FOREIGN MATTER -  
The above items were found in the plunger,  
"C" batteries were resting on the plunger

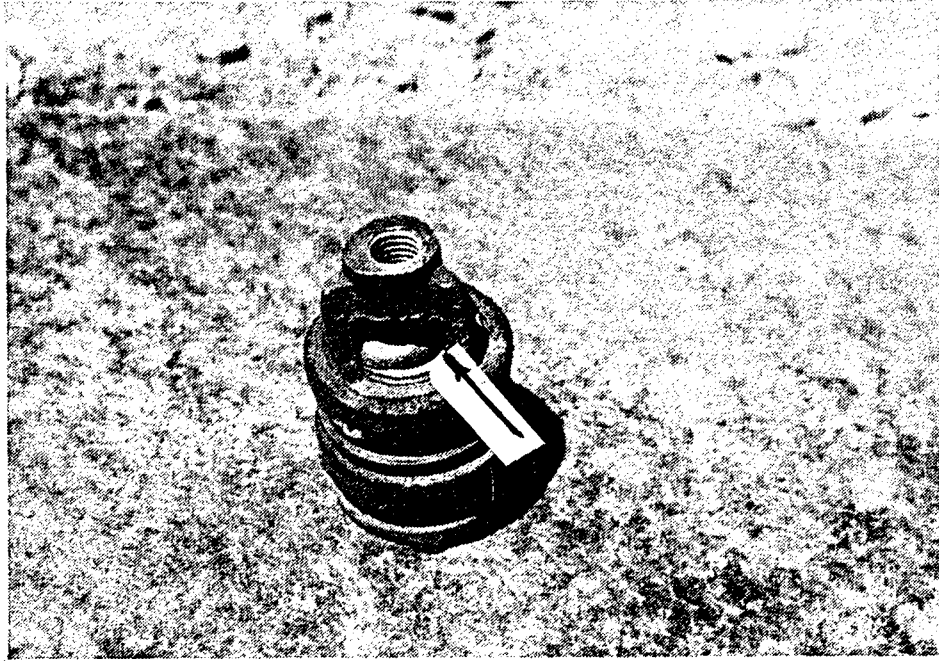
- o Problem Area 2 (15 percent) - Due to a defective plunger poppet valve, failures occurred when the valve got stuck between two legs of the cage or did not completely cover the valve seat. This is an apparent design problem.

- PLUNGER POPPET VALVE FAILURE -  
Plunger poppet valve not covering the valve  
seat thus causing loss of pumping efficiency

It is recommended that the plunger poppet valve failure be corrected by increasing the diameter of the top of the poppet as well as increasing the diameter and length of its shaft, to provide a better seal and to prevent it from getting stuck between two legs of the plunger cage. Additional poppet valves should be manufactured to replace those in the field.

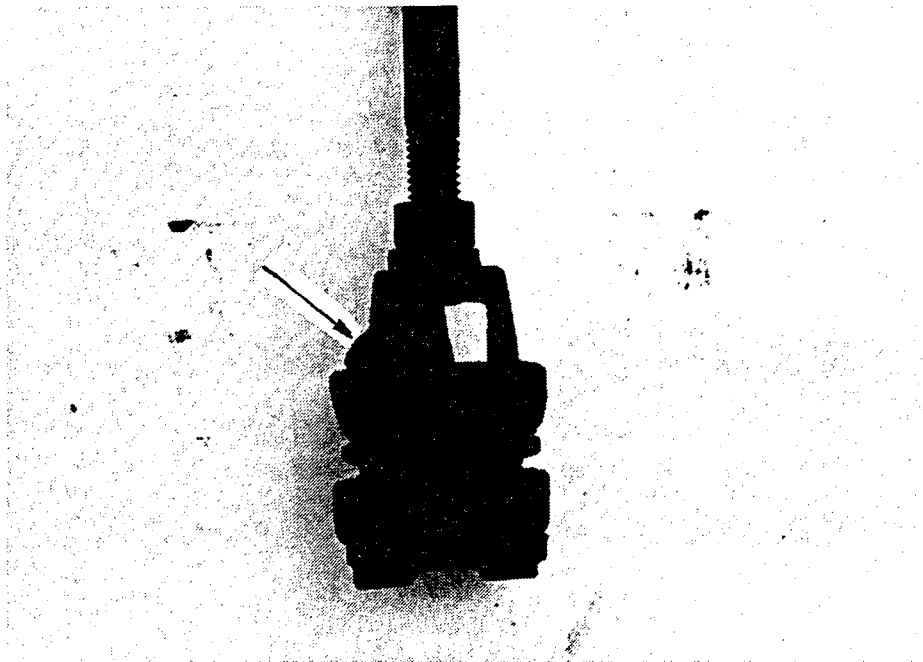
- PLUNGER POPPET VALVE FAILURE -  
Plunger poppet got stuck between two cage  
legs preventing lifting of the water column

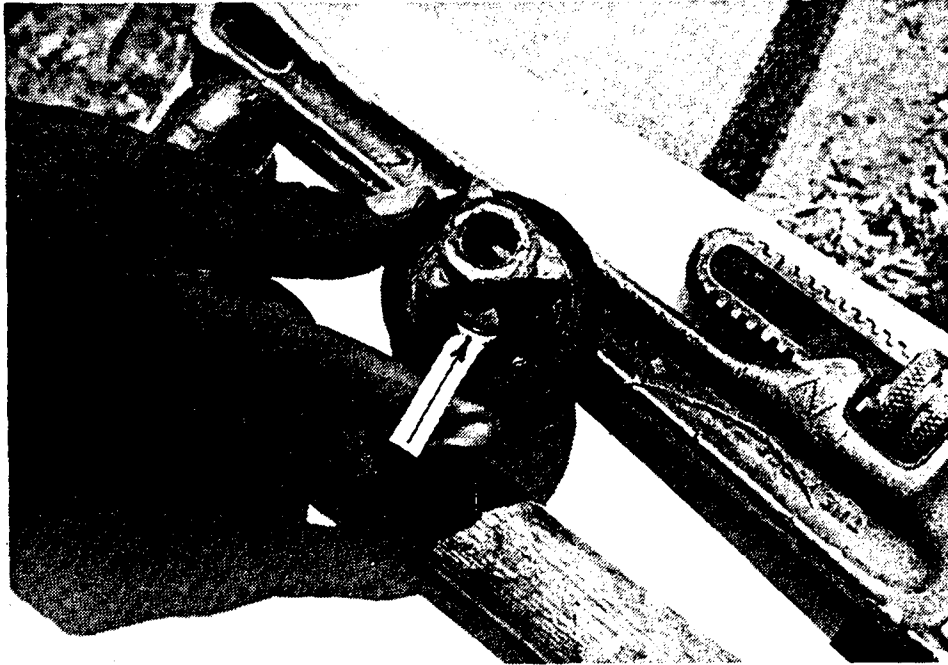
- PLUNGER POPPET VALVE FAILURE -  
Plunger poppet valve not covering the valve  
seat thus causing loss of efficiency

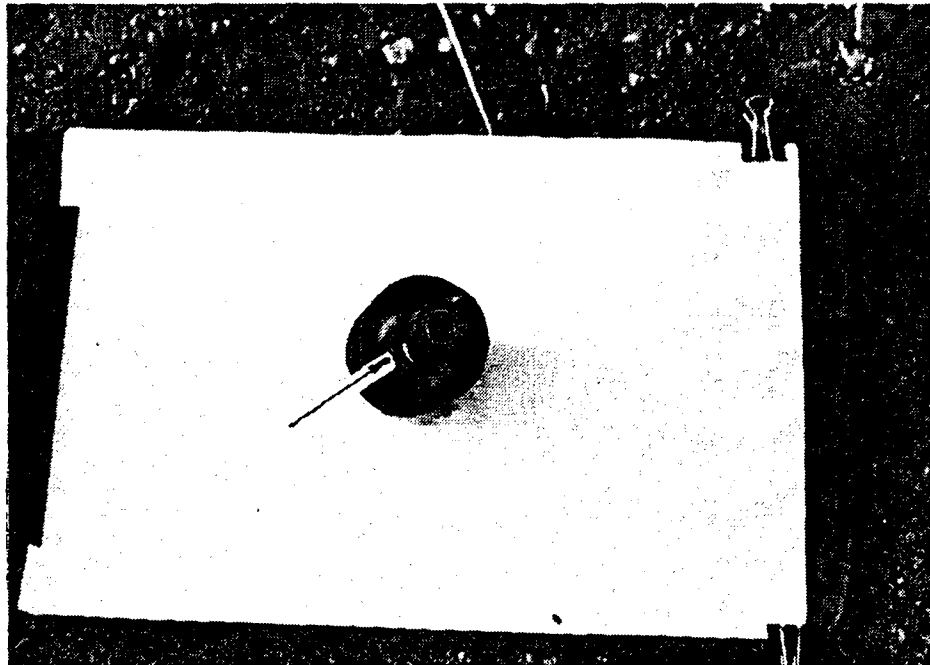
- PLUNGER POPPET VALVE FAILURE -  
Another site with the above problem

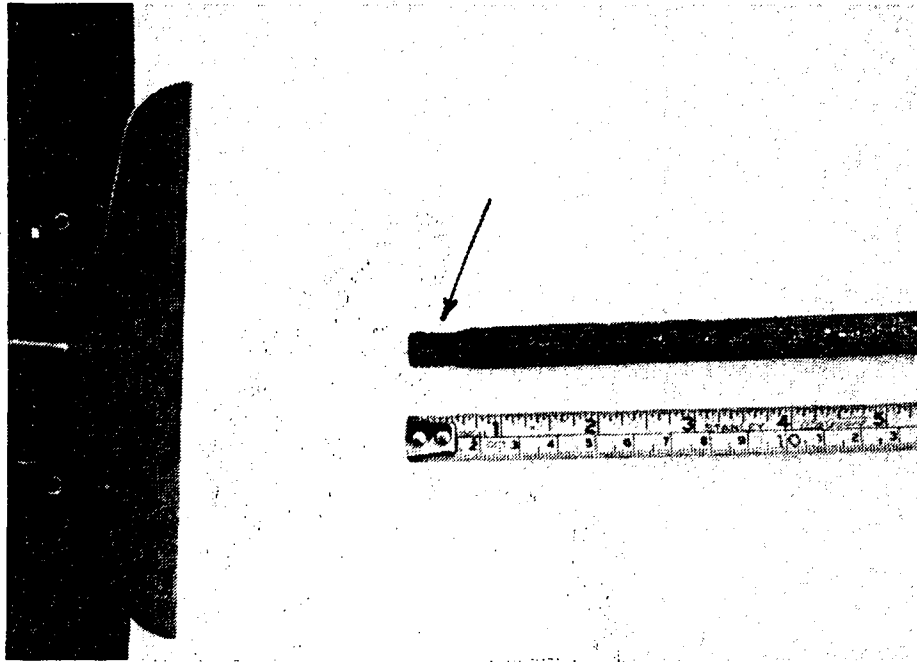
- o Problem Area 4 (15 percent) - Plunger rod separation was found in six cases. In two cases, the plunger rod had separated from the rod end. In three cases, the separation was at a coupling between rods. In one case, the separation was at the plunger assembly.

- SEPARATION OF DROP ROD FROM "T" COUPLING -  
Defective drop rod section end threads caused  
separation of plunger rod

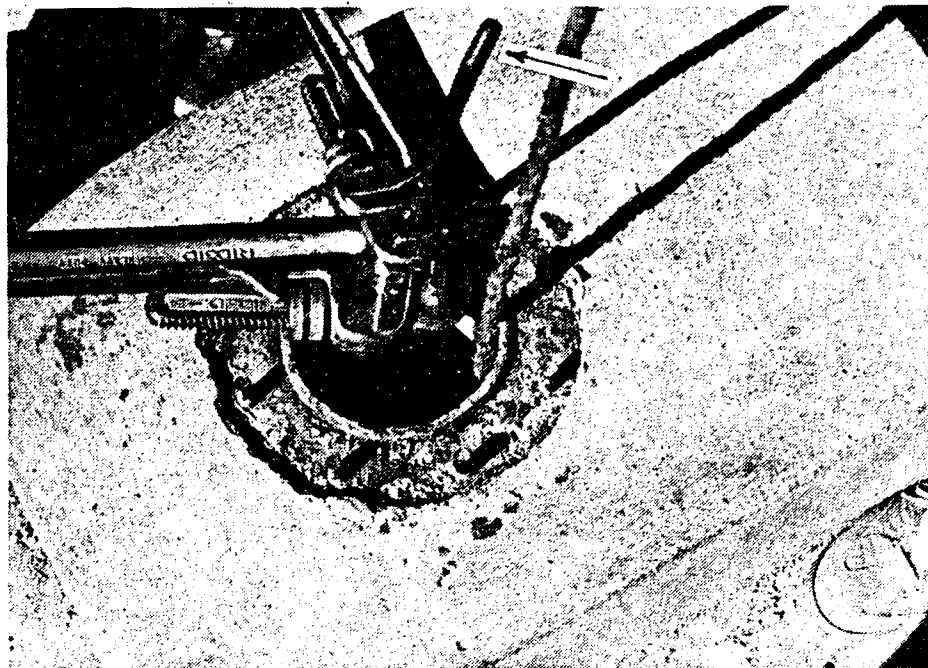
- SEPARATION OF DROP ROD FROM "T" COUPLING -  
Another site where the above problem occurred

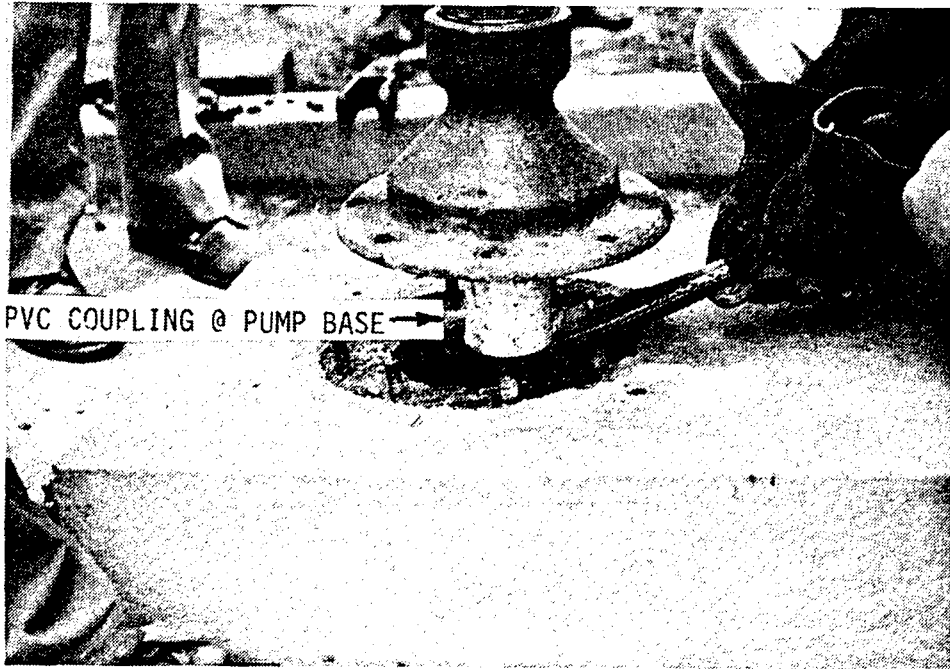
- PVC DROP PIPE SEPARATION -  
PVC drop pipe separated from the PVC adapter

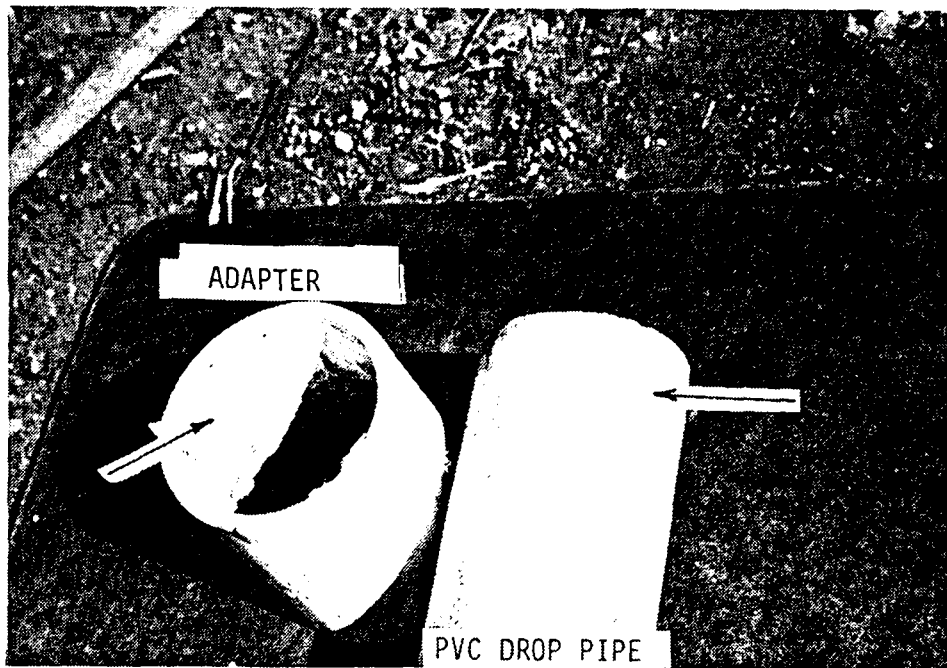
- PVC DROP PIPE SEPARATION -  
These samples show little if any PVC solvent  
action on the surfaces

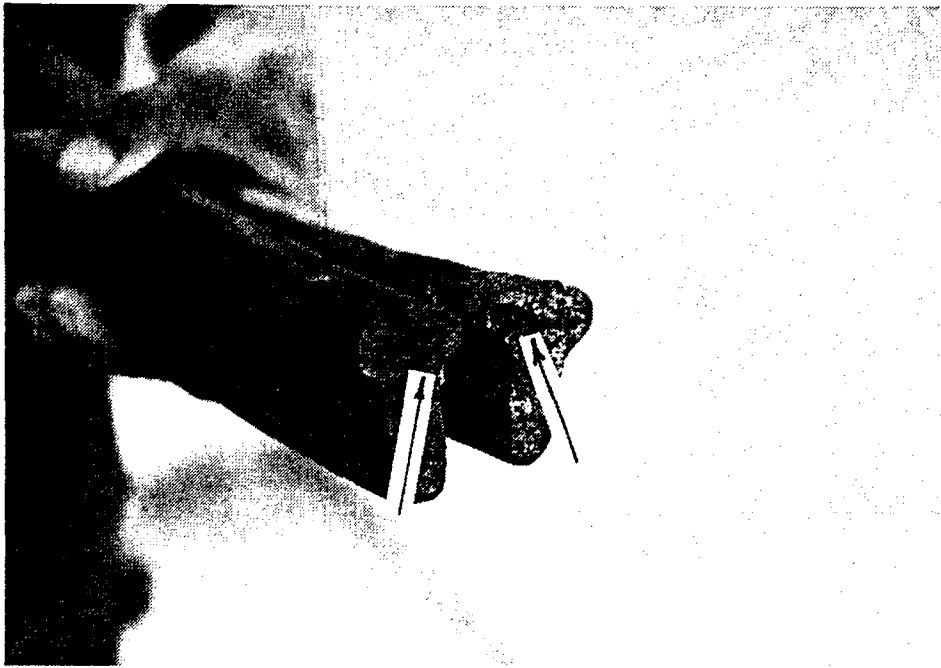
Hand pump handles have been breaking as a result of porosity as shown by arrows. These voids weaken the handle.

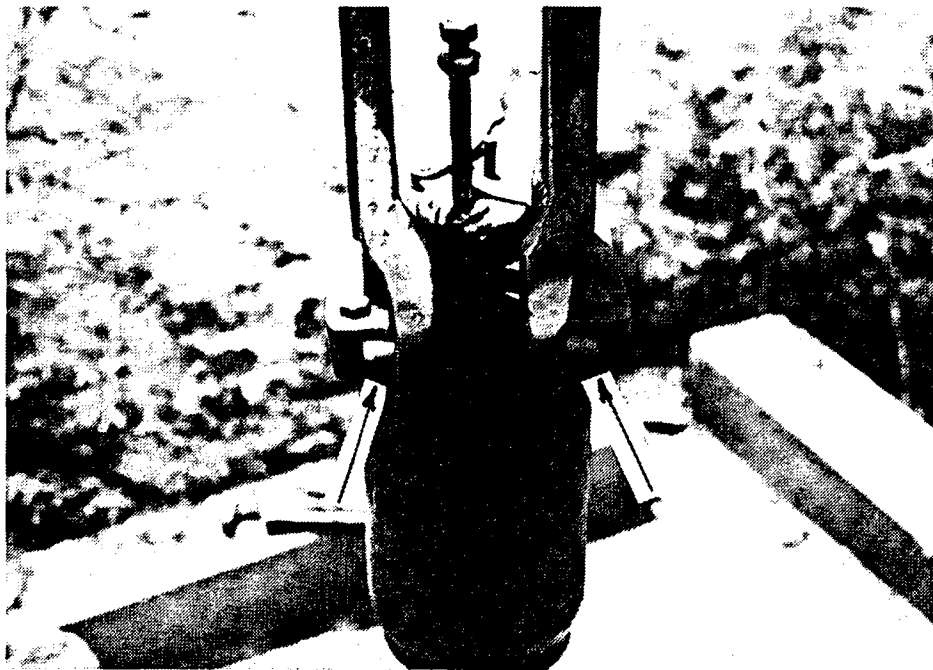
Arrows indicate the loose bushings. These should be press-fit and should not fall out as shown above

Additional cap assemblies should be manufactured to replace those in the field with loose bushings. The leather flapper foot valves should be replaced with metal popper/rubber seat foot valves in the AID handpumps of conventional design that were installed before the modified pump.

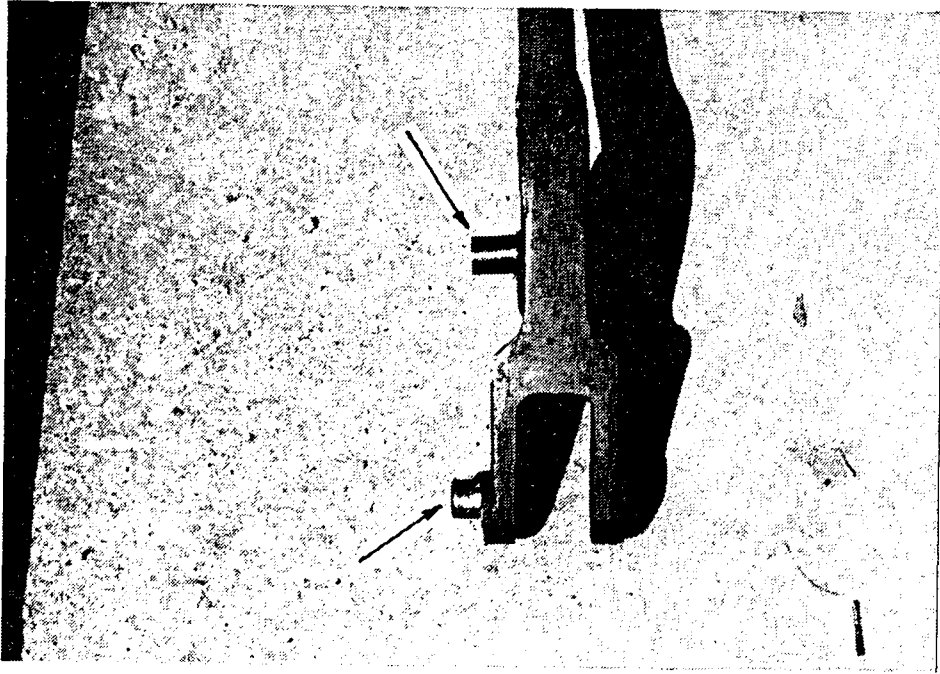
Arrows show loose bushings

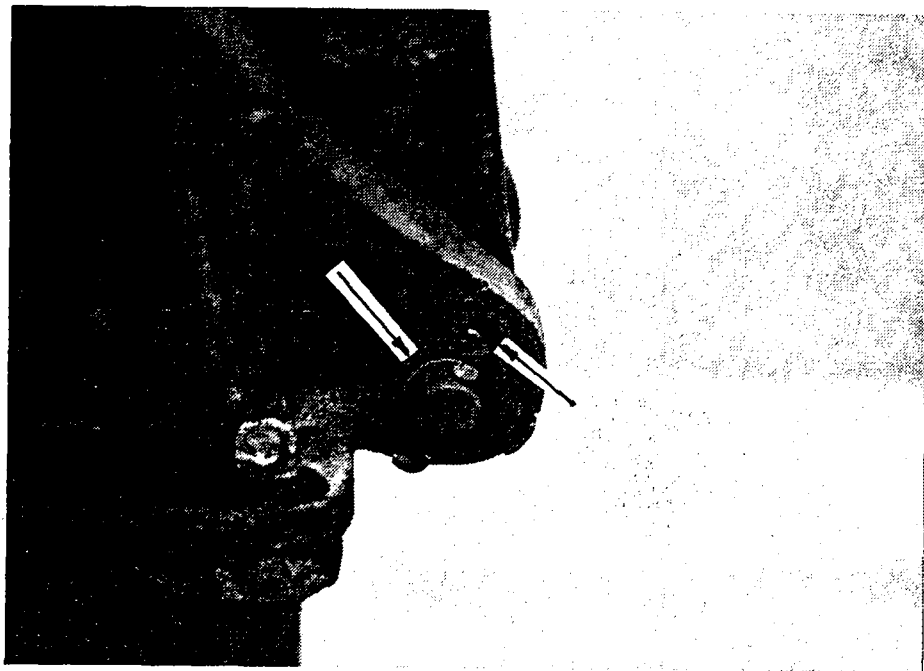
Arrows indicate oversized bushing hole and porosity

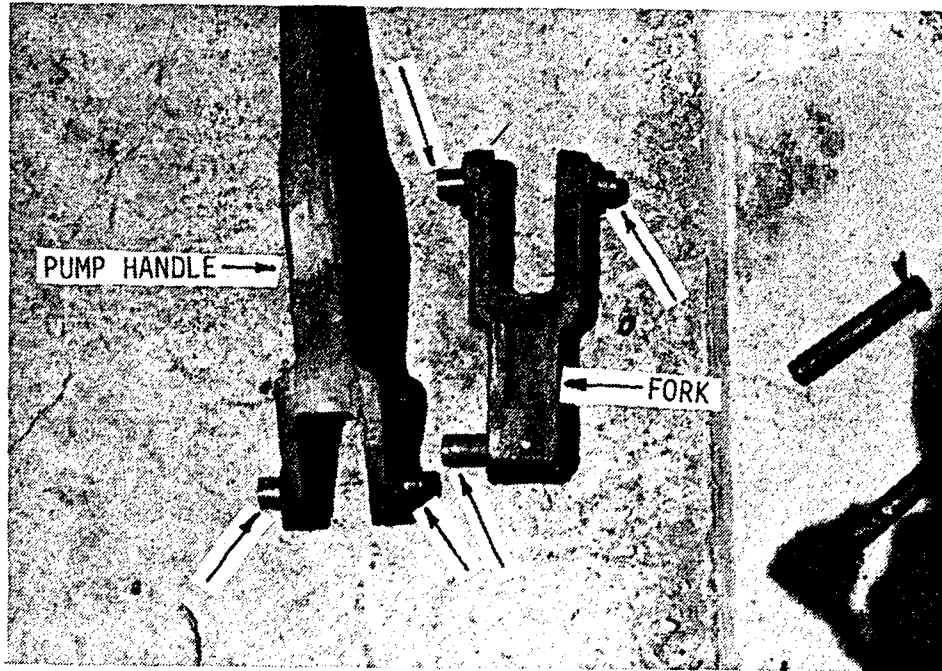
Loose bushings on handle and fork

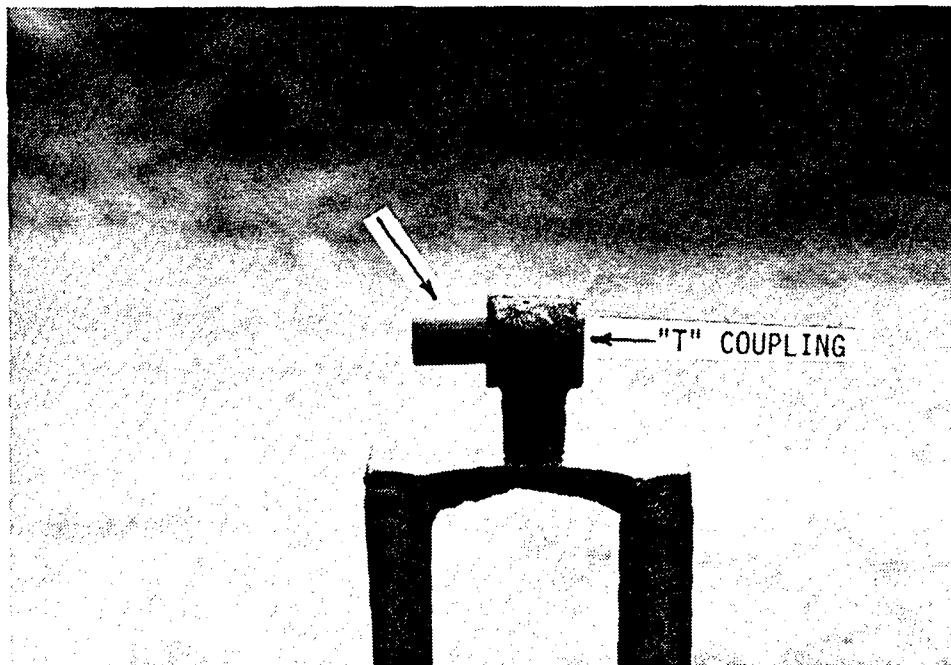
Loose bushing on "T" coupling

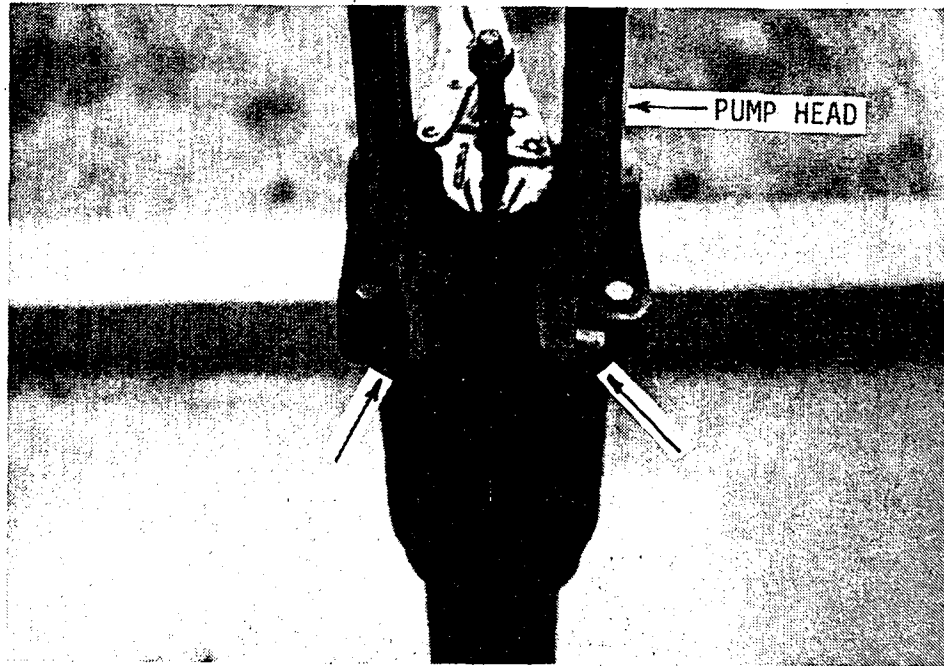
Another site with loose bushings on the pump head

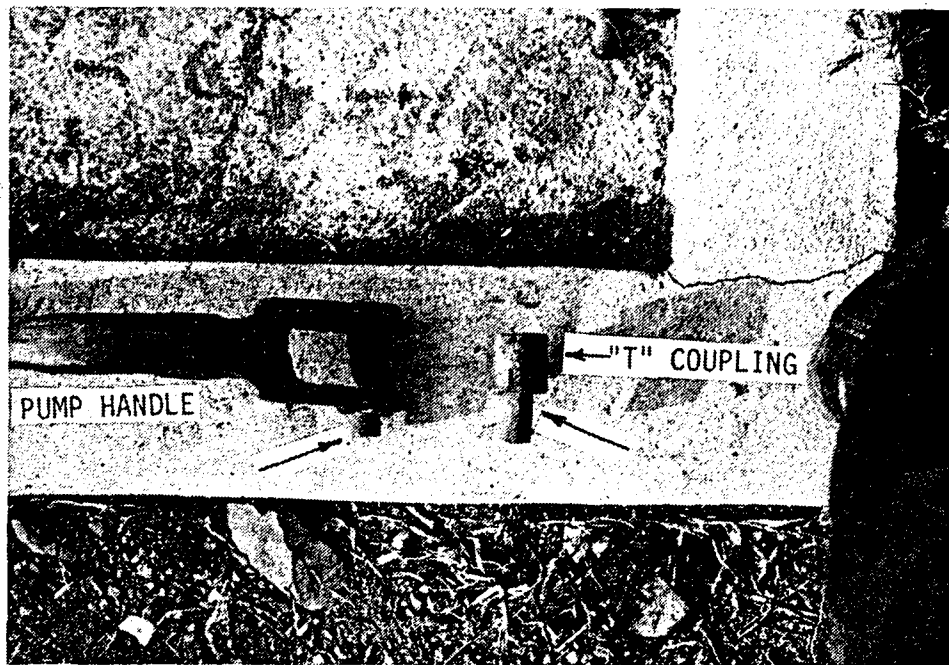
Another site with loose bushings on pump handle and "T" coupling

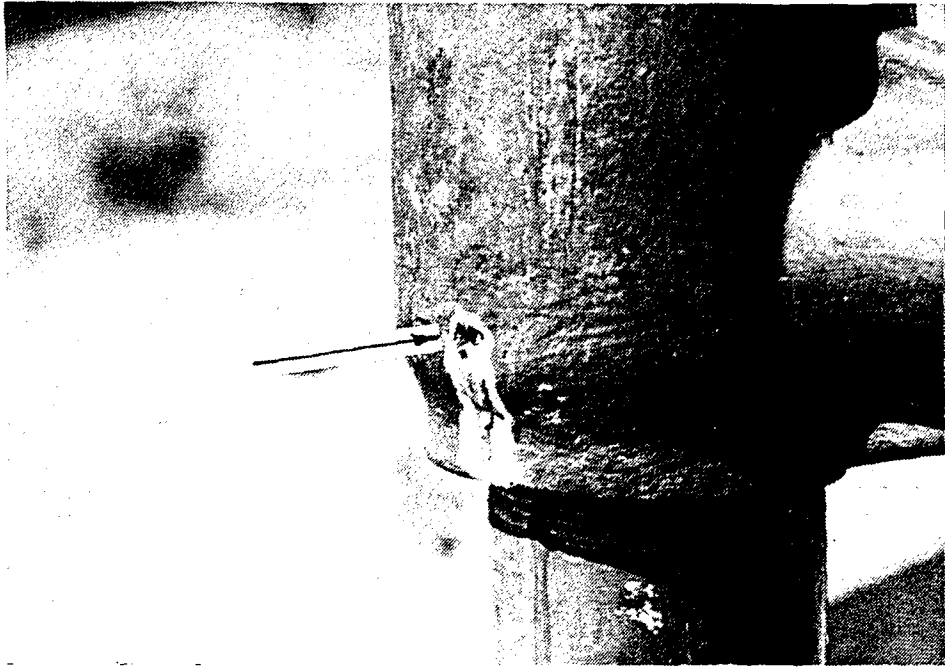
Several hand pumps had porosity in the pump body which allowed leakage of water

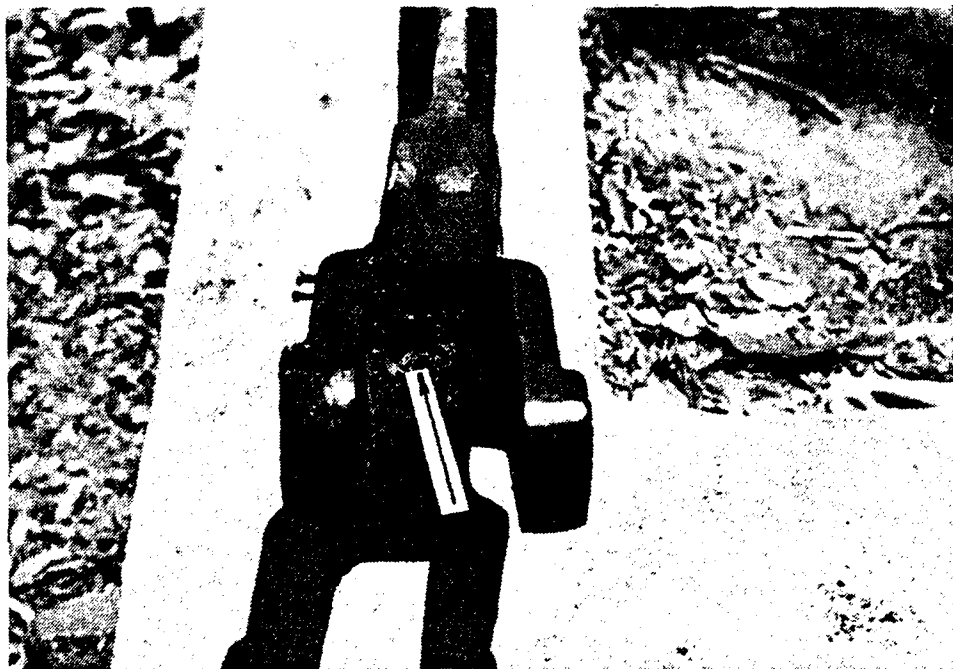
Arrow shows porosity

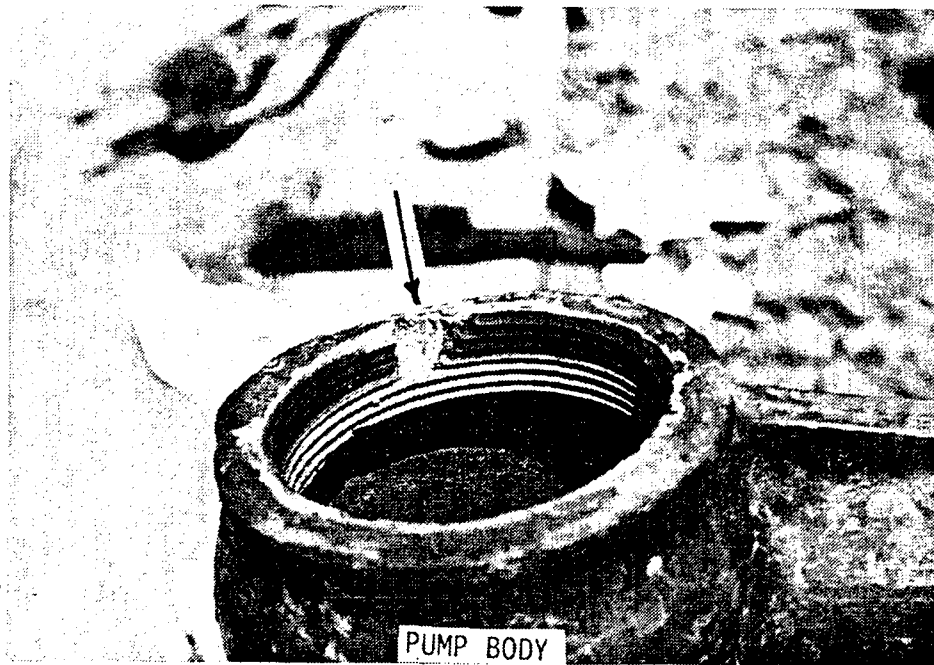
Defective threads on hand pump body causing water leakage

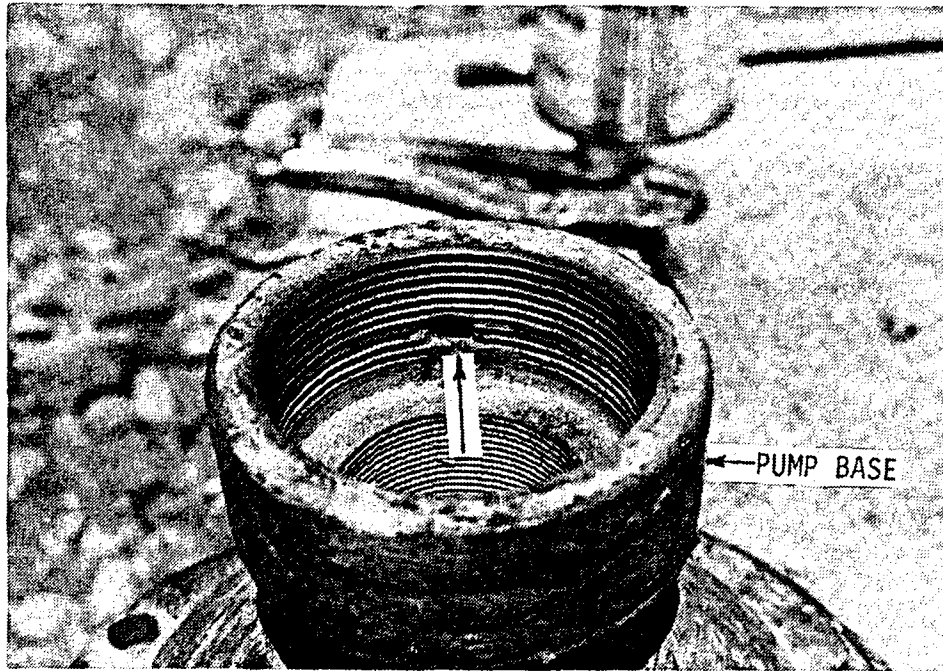
Porosity on interior pump base upper threads causing water leakage

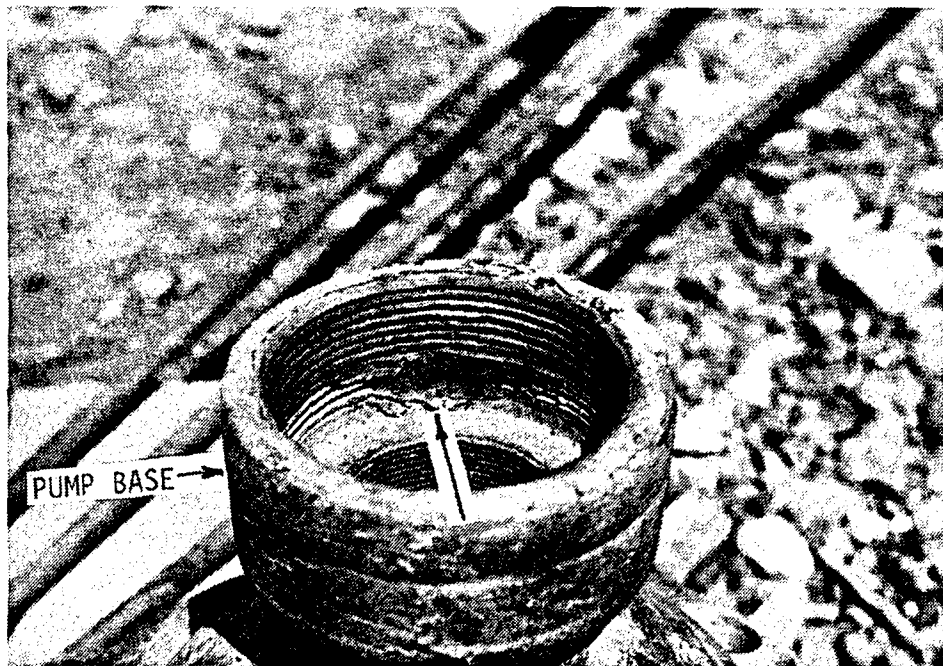
Arrow shows plaster placed by manufacturer to cover porosity. Pump was accepted and installed as shown.
