# STATUS OF THE AID TYPE HANDPUMP IN THE DOMINICAN REPUBLIC

WASH FIELD REPORT NO. 98

AUGUST 1983

Prepared for:  
USAID Mission to the Dominican Republic  
Order of Technical Direction No. 143

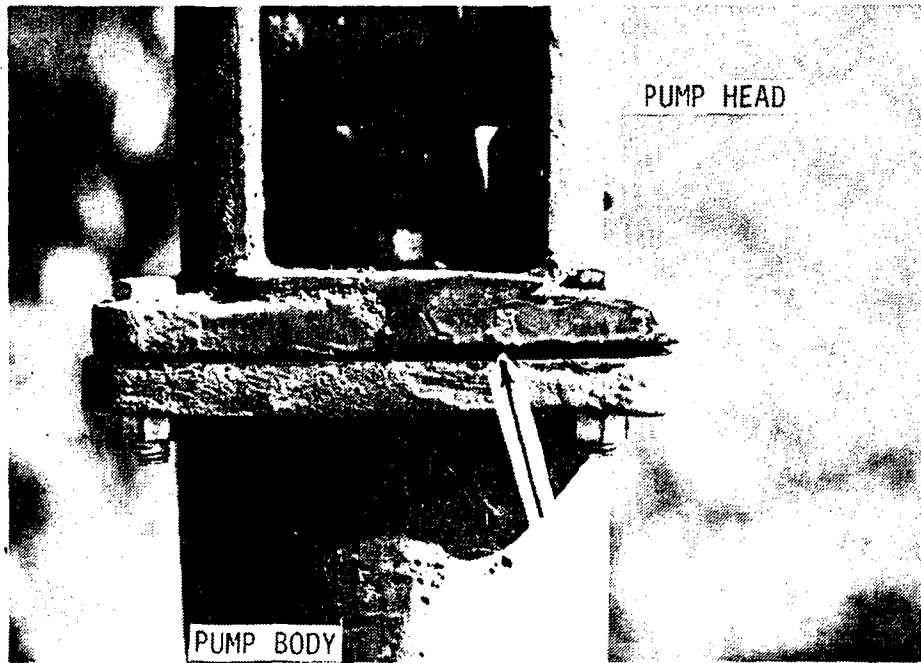
Plaster placed by manufacturer to cover severe porosity

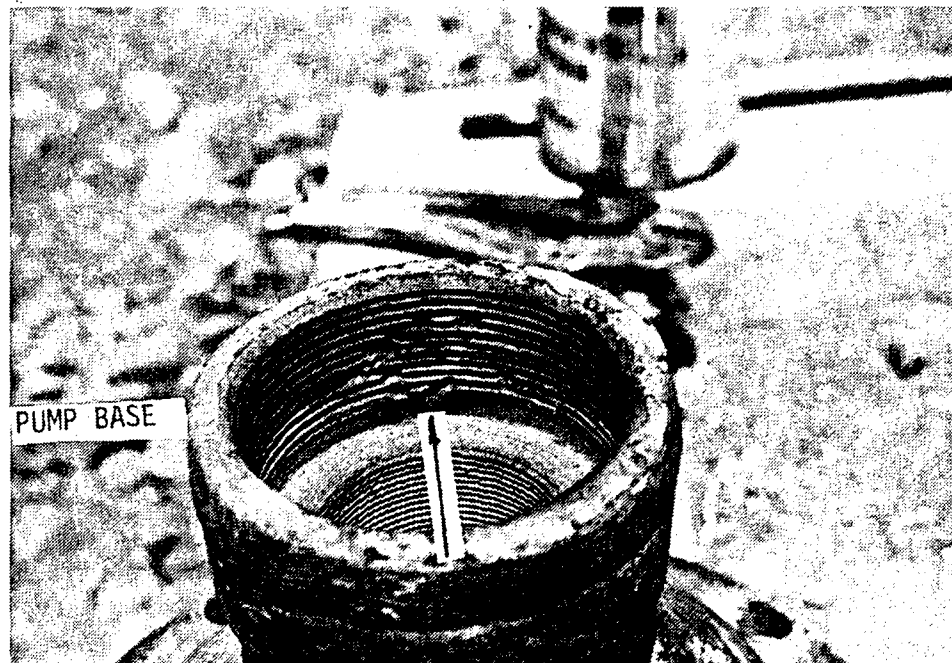
Another site with the porosity problem on the upper threads of the pump base. This causes excessive water leakage.
