REPORT ON TRIAL
OF WAVIN HANDPUMP IN INDONESIA

PREPARED BY
DIRECTORATE OF WATER SANITATION
MINISTRY OF HEALTH
GOVERNMENT OF INDONESIA

UNITED NATIONS CHILDREN'S FUND (UNICEF), JAKARTA, INDONESIA

September 1988

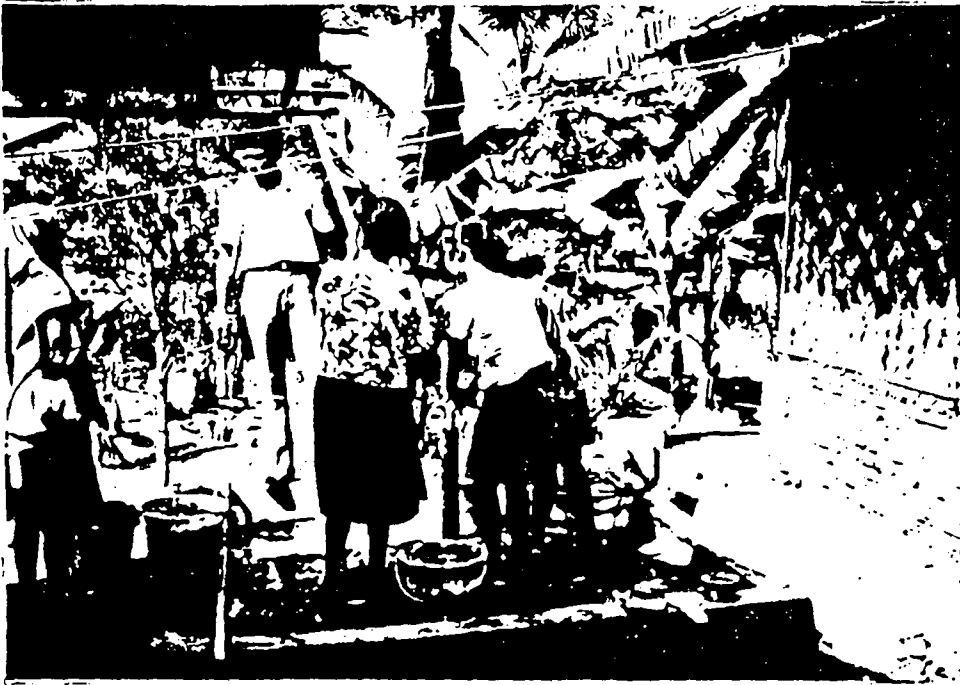
Use of PVC components, light weight, and simple design makes the Wavin pump easy to install and dismantle for repairs. The only tool needed is a driver. Technical persons are not needed for this job and can also be by women. See picture above showing three women dismantling the pump.

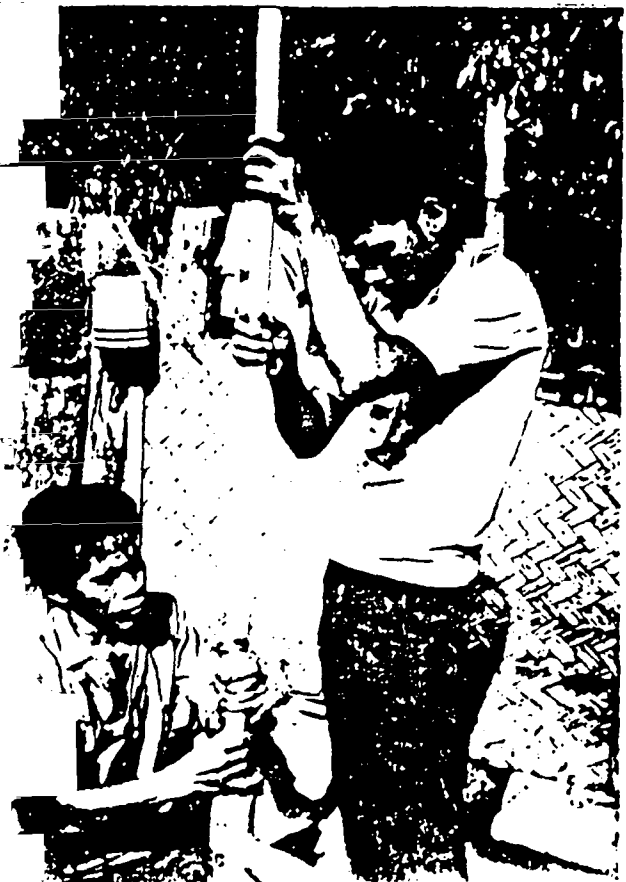
Picture in the left side shows two caretakers connecting the pump rods to install back the pump after replacing the damaged ramme cord seals. Note that special pipe handling tool and technical persons are not required to install these pumps.

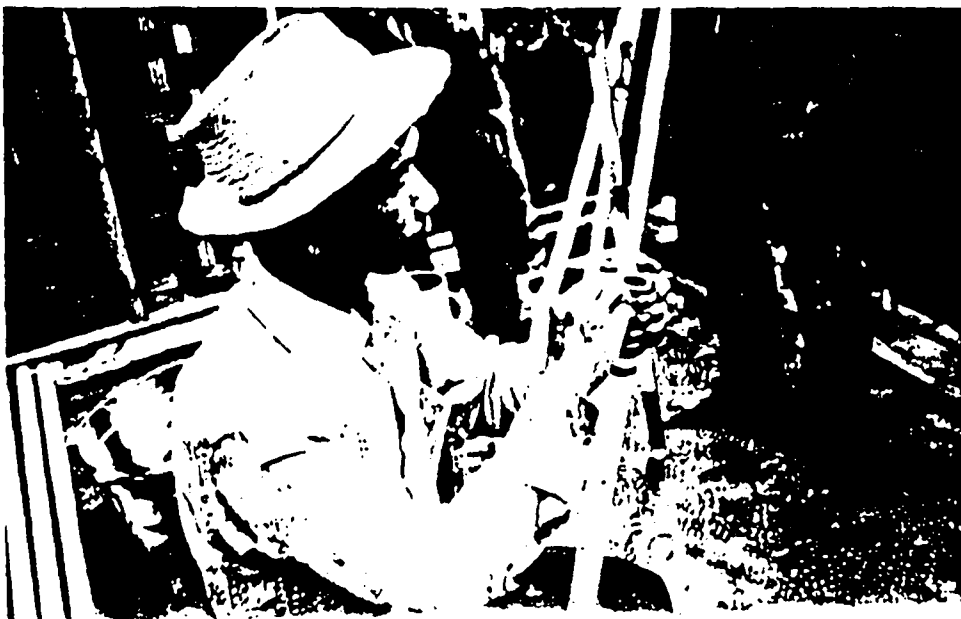
Picture below shows a caretaker fixing a new ramie cord seal on the pump. Some pump owners used wick of the kerosene stove as substitute for ramie cord seal supplied.

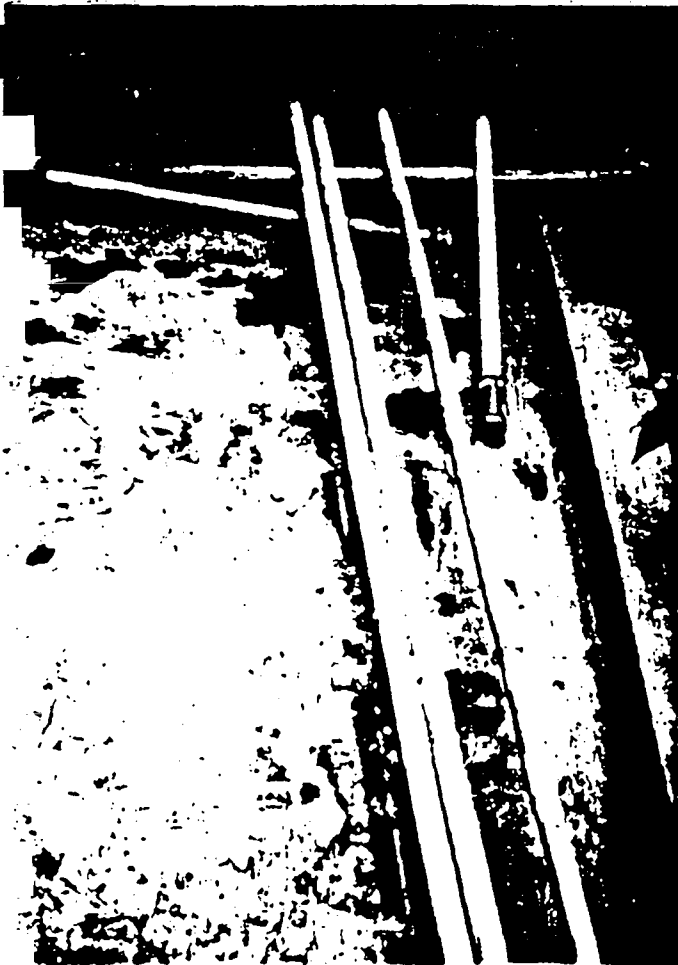
After 8 months of usage, the centralisers were the only component on which visible wear and tear was observed. Centralizers from the top most pump rod and the rod following it, were found to be rubbing against the riser pipes. In three or four pumps these were found to loosen off from the epoxy joints. Also, the pump rods, riser pipes were found to be stained yellow with the deposition of iron oxide which could be cleared with some efforts (See picture in the left side).

- (iii) Pump rod centralizers and cylinder lining : In almost all the pumps opened, one or two pump rod centralizers at the middle of the rod came off because of poor epoxy joints. The centralizers especially on the top most and bottom most pump rod showed signs of rubbing against the cylinder wall. However, there was no sign of visible damage or abrasions. The inner walls of the cylinder and riser pipe were found to be smooth, except for one pump (no. 15) which showed signs of abrasions at the top section of cylinder lining. The centralizers seems to be helping in minimising buckling of pump rod during its downward movement.
