A study of hafir linings in Darfur Province, Western Sudan

Report No OD/10

August 1977

Hydraulics Research Station
Wallingford
England

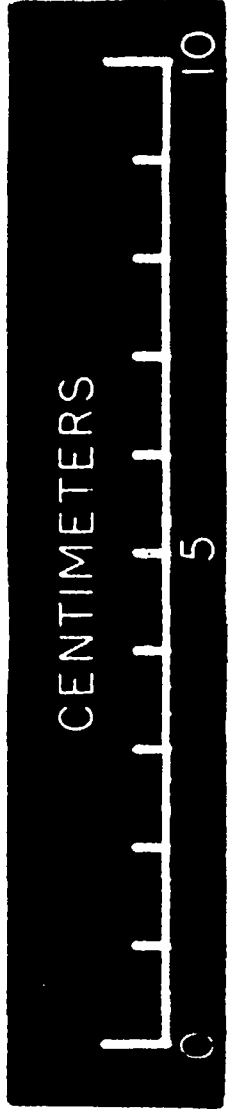
- 7.4.3 In all hafira, the adhesive tape was found to have been damaged in a way which suggested termite attack (Plate 21). Damage to the mastic tape was not so obvious (Plate 14). It was noted that the exterior adhesive tape was, in places, degraded while still attached to undamaged polythene. This suggests that the termites could be attracted to it for food, a possibility which requires further expert investigation.

PLATE 14 Sample of mastic tape from hafir B
