# HANDPUMP TESTING AND DEVELOPMENT

## Part 5. The Second Year- Results of Completed and Ongoing Test

by  
**Robert Hahn**  
**Per Johansson**

**Lund Sweden 1985**

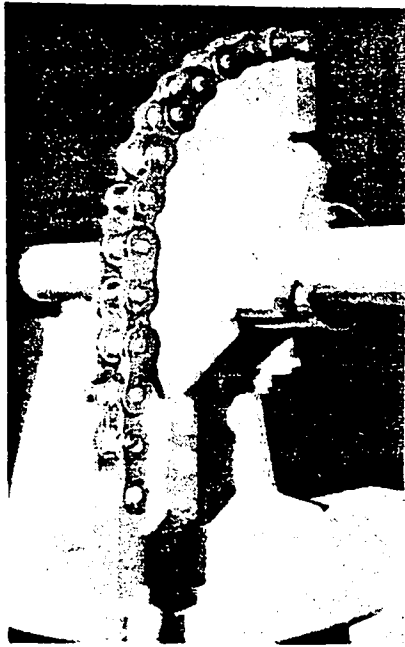
This chain fitted according to figure 3.1 is standard in both SWS and IM II pumps. The chains installed in the test rig showed a tendency to get stiff after a few months. After cleaning and boiling in a mixture of grease and graphite, the chains operated smoothly. Chains installed in new handpumps are treated with grease and graphite boiling, which clearly proved to be necessary.

Figure 3.1 Standard SWS roller chain.

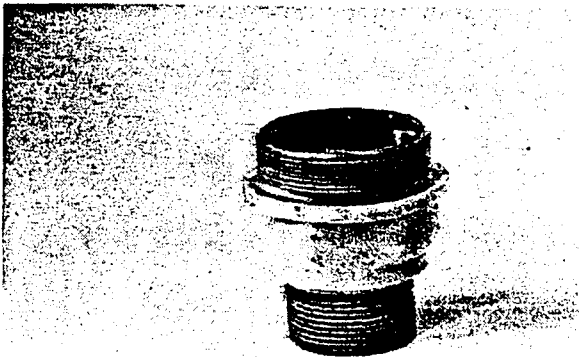
The POM valves all operated well. The PVC valves, however, were all broken down during the test. Cracks occurred at the valve seat or at the threads.

Figure 3.18 The POM valve
