LEAKAGE CONTROL IN WATER DISTRIBUTION SYSTEM
OF ADDIS ABABA

by Azeb Asnake

Leakage control in water distribution system of Addis Ababa. Tampere University of Technology, Institute of Water and Environmental Engineering. Publication C . 79 p.

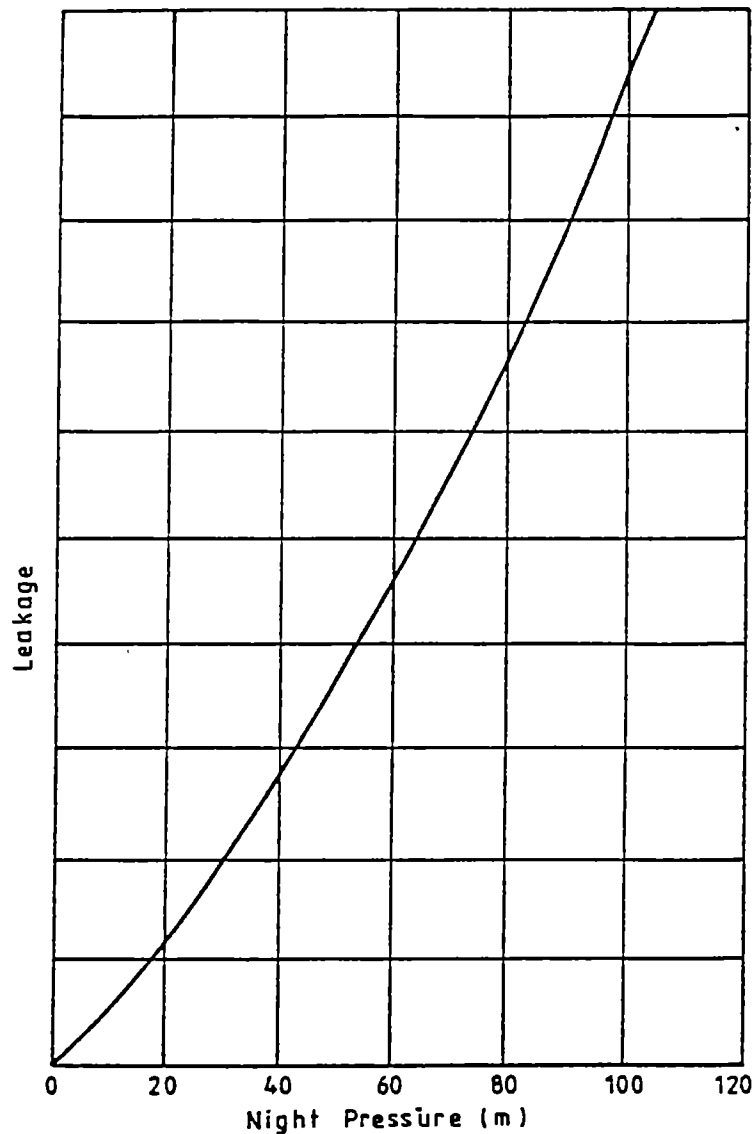
Figure 1. Relationship between leakage (net night flow) and pressure (Ridley 1982).

Figure 1 shows the relationship between pressure and leakage graphically. The curve demonstrates that pressure reduction reduces leakage and also that the effect is greater at higher pressures (Goodwin 1980).

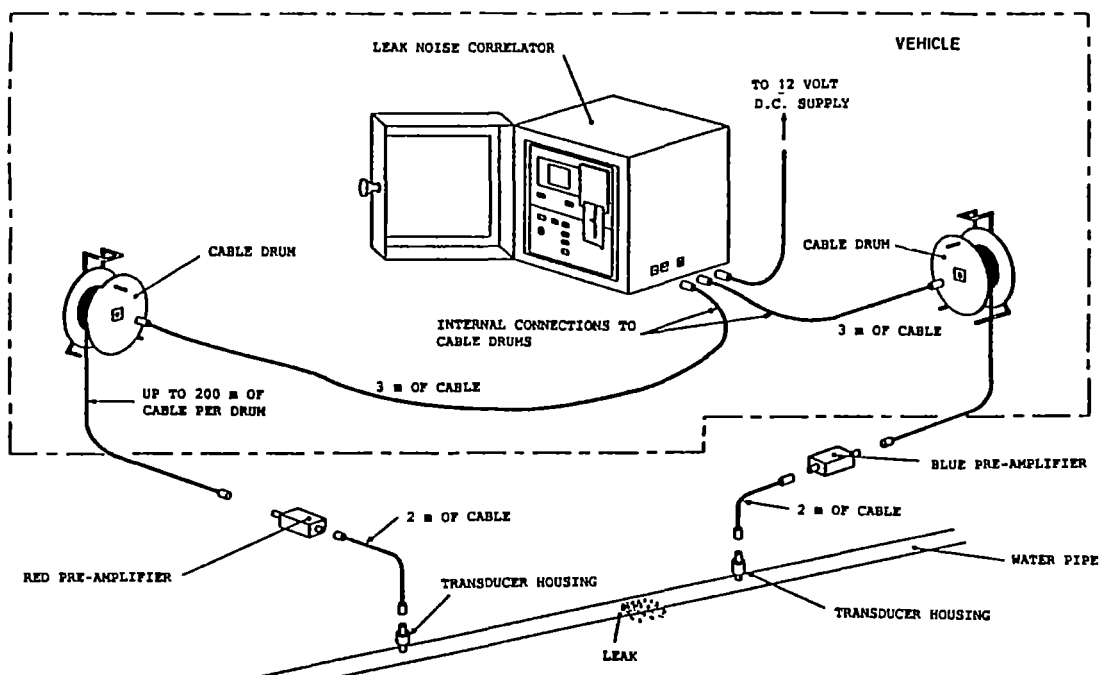
Figure 3. The leak noise correlator (Iikkanen 1988).

This technique involves the use of a leak noise correlator (Figure 3) with two microphones for pin-pointing the position of underground leaks by comparing the signals using the process of correlation (Grunwell and Ratcliffe 1981). The noise produced by a leak is detected at two positions along the main line on either side of the leak. The difference in time taken for the noise to reach the two positions is determined by the correlator. From the time difference, the distance between detection points and the

velocity of sound in the pipeline, it is possible to determine the exact position of the leak. This device has many advantages, such as more accurate location of the leak, less dependence on operator interpretation, and possibility to use in areas with a high background noise, thus allowing leak location during the day in areas of busy traffic.

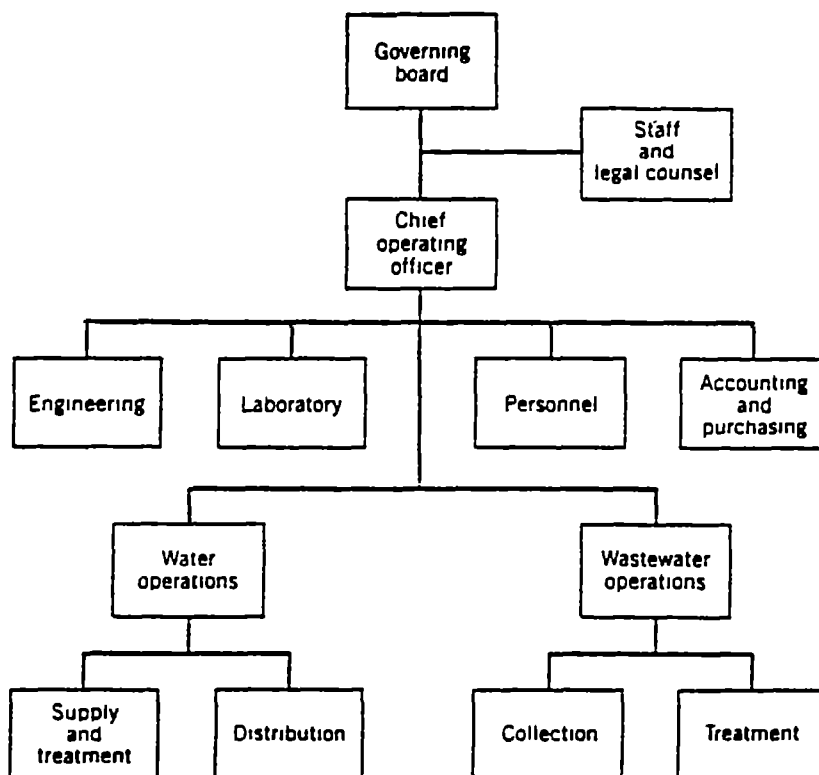
Figure 5. Generalized water and wastewater utility organization (Grigg 1986).

A generalized internal organization of water and wastewater utility proposed by Grigg (1986) is shown in Figure 5. This structure can apply whether the utility is private or public.

In this structure, various study and design functions can be accomplished by the engineering department. Depending on the size and complexity of the water utility, other staff can be distributed around the organization. In larger utilities there may be a need for a separate and permanent training department if the problem of reducing wastage of water is to be tackled efficiently. A measurement and loss control department is advisable in the larger utilities to ensure effective loss control (Twort et al 1985).

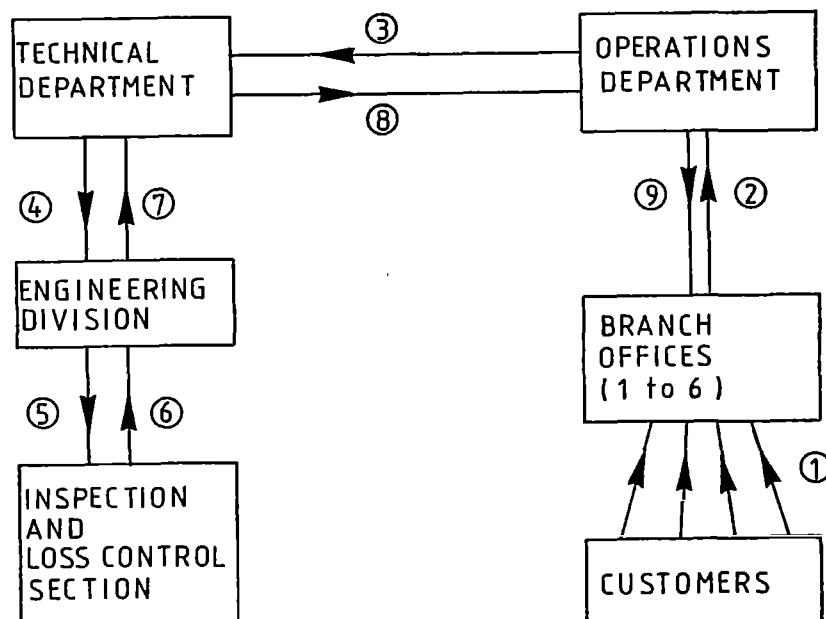
Figure 11. The information flow in Addis Ababa Water and Sewerage Authority might sometimes be quite slow including several steps.

In cases where leakages are detected by the inspection and loss control crew, the crew leader has to report to the Engineering Division and this division has to forward the case to the Technical Department. Further the Technical Department has to inform the Operations Department which later transmits the report to the concerned branch office. Finally repair instructions are transmitted to the technicians. This procedure takes quite a long time before the leak is repaired and in most cases the feedback is not effected. The worst case of flow of information is presented in Figure 11 to point out the unnecessary time consumption resulting from the present organizational set-up. The numbering shows the sequence of information before any activities are done following the customer's complaint.

The whole round from 1 to 9 exceeds three to four months especially with invisible leakages before appropriate measures are taken. In case of visible leakages, control is

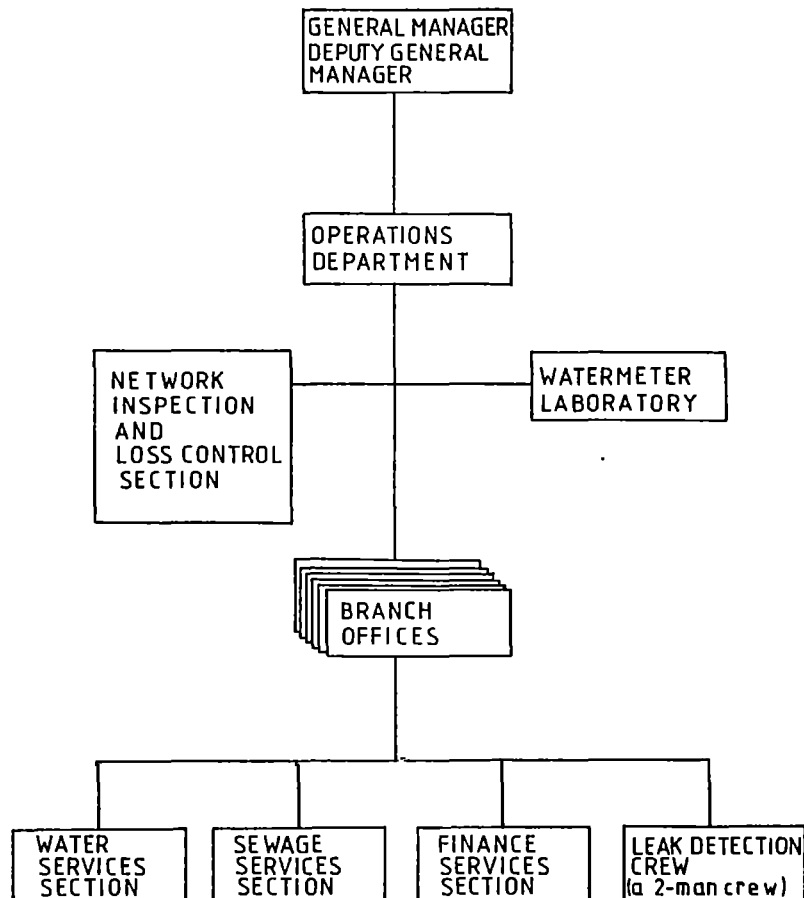
Figure 12. Proposed organization for the Network Inspection and Loss Control Section in Addis Ababa Water and Sewerage Authority.
