**THE INTRODUCTION OF  
RAINWATER CATCHMENT TANKS  
AND MICRO-IRRIGATION  
TO BOTSWANA**

**INTERMEDIATE TECHNOLOGY  
DEVELOPMENT GROUP LTD.**

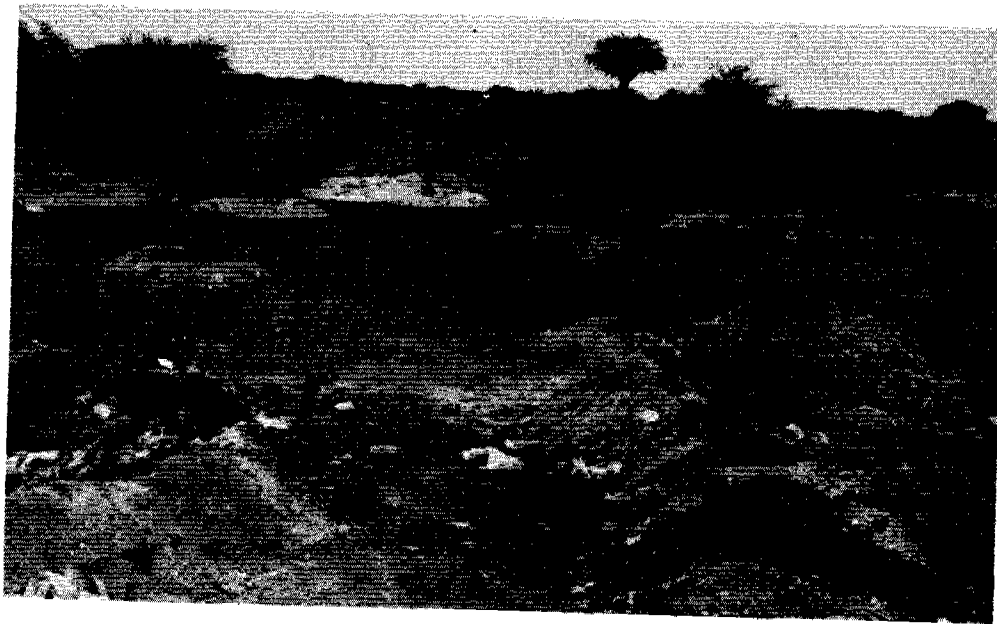
*PLATE 9. Guava Tree Plantation at Radisele. The plantation is in the course of construction.*

The guava trees were planted in an area of about 500 sq. yds. of land 'upstream' of the inflow of the 'first' tank. This area was levelled so that the flow of water over it would be as slow as possible; the ground was covered with a mulch of perforated polythene and gravel—

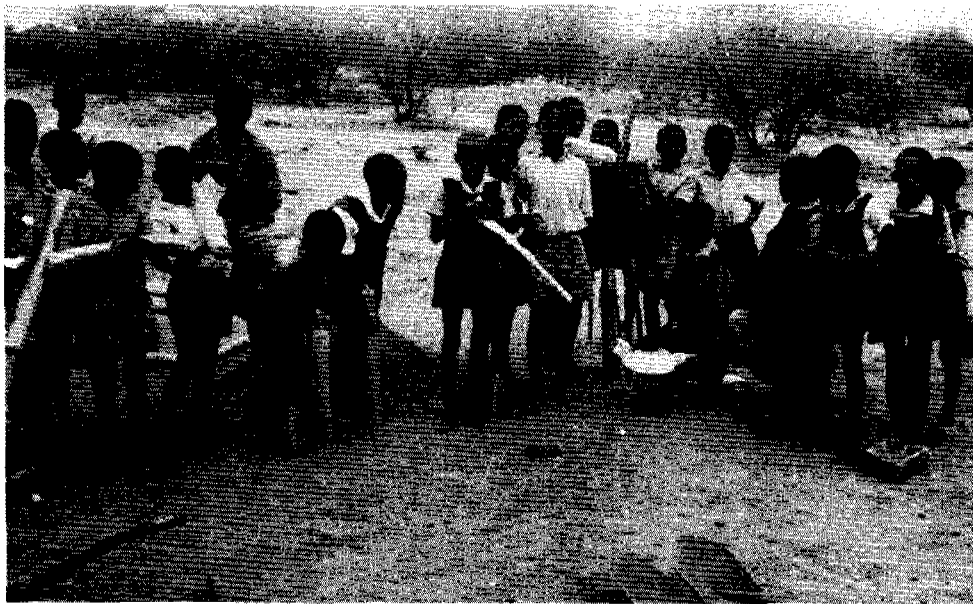
*PLATE 17. Children filling the sausages at Moineedi School. A simple hopper has been set up to increase the speed of work, which is being done by both boys and girls.*
