REPORT
ON

RAINWATER CATCHMENT PROJECT JAMAICA

November 1973

Water Resources Division
Ministry of Mining and
Natural Resources
Government of Jamaica

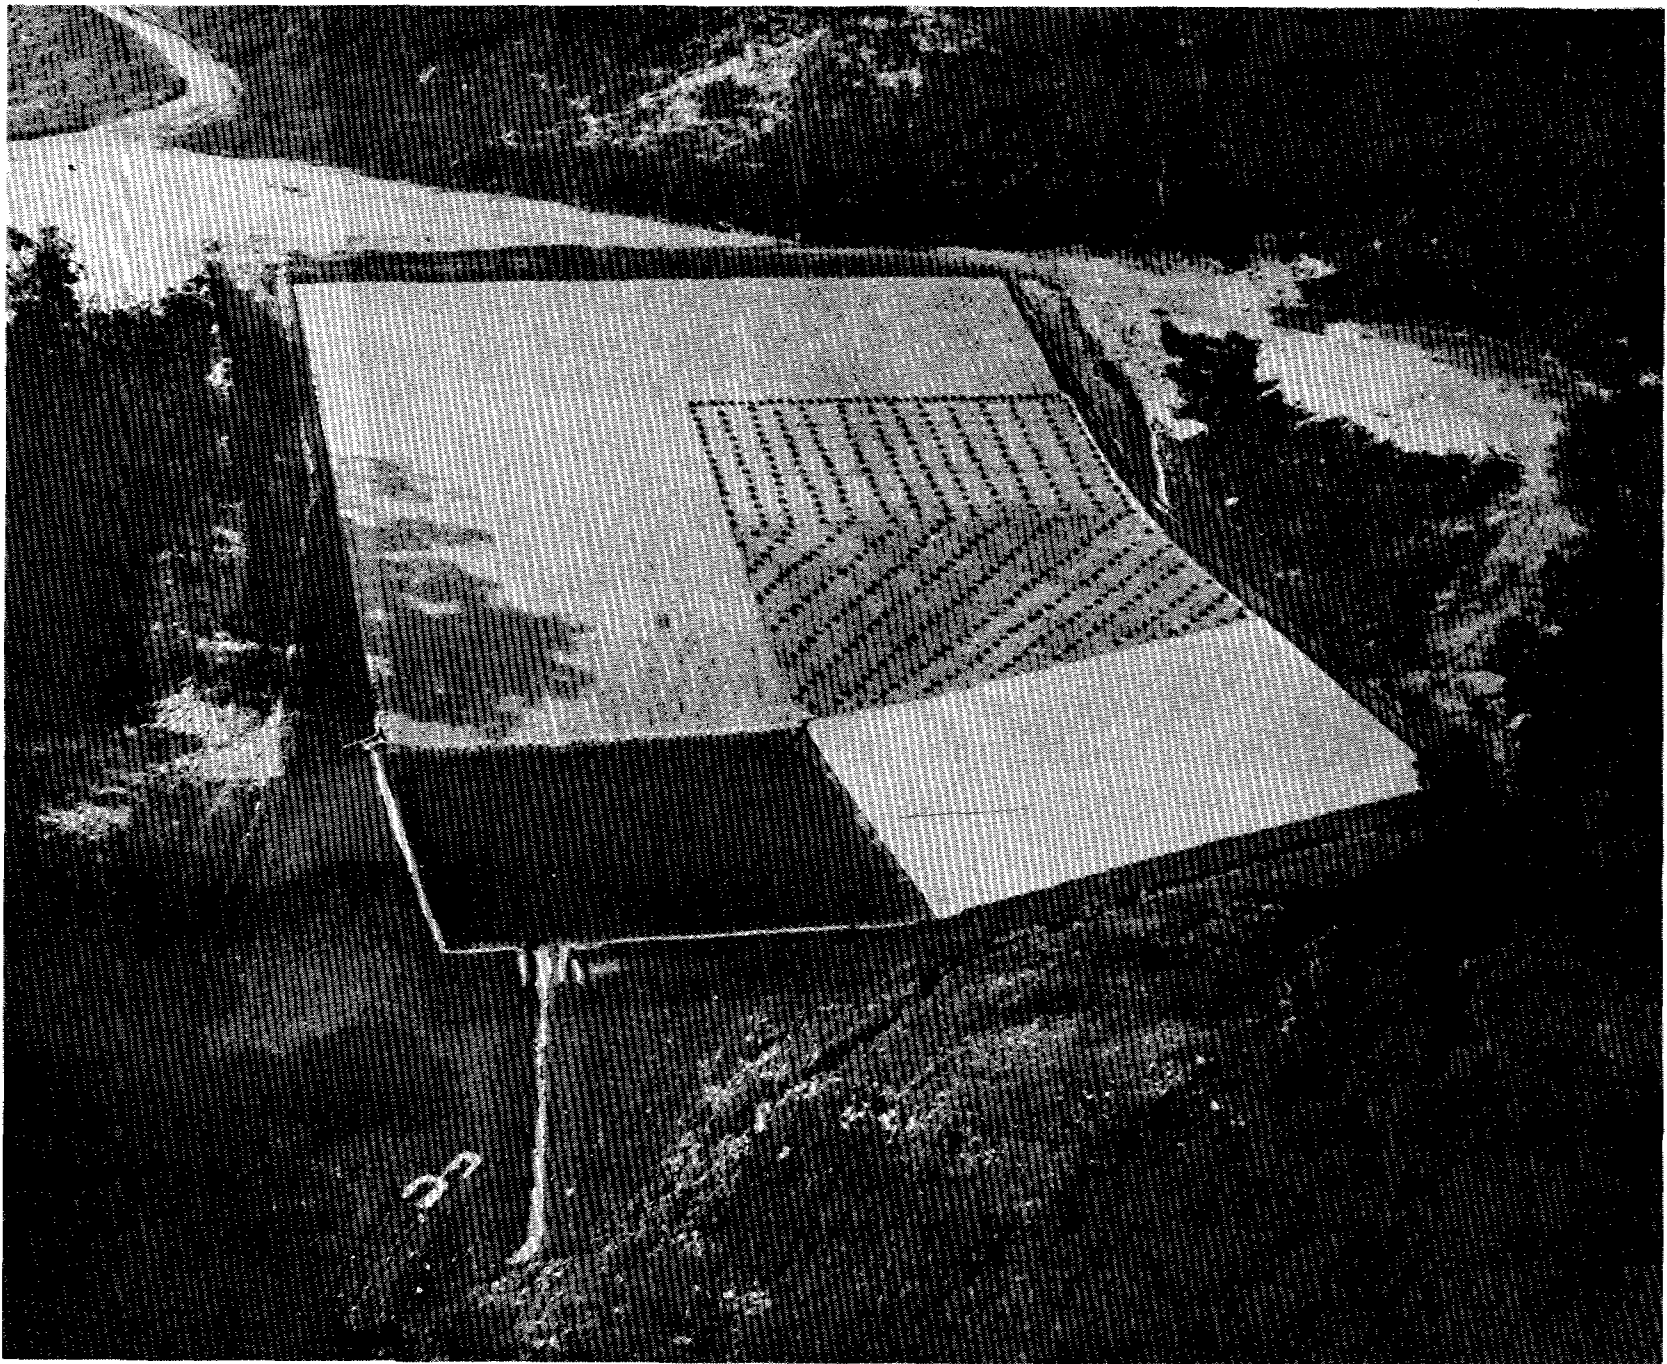
CATCHMENT STORAGE AT WK.10 UNIT, OCTOBER 1973.

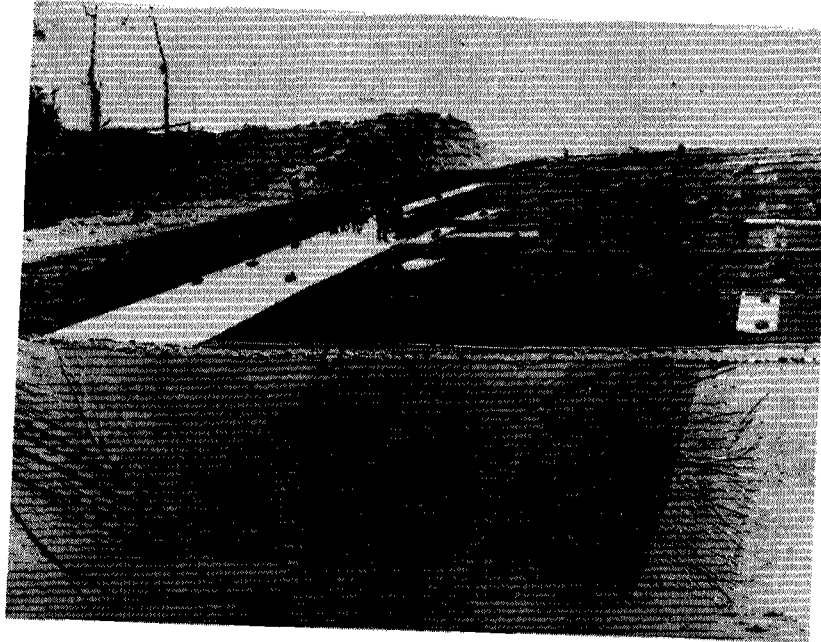
3. *Laying aluminium sheet on the catchment apron, March 1973.*

The aluminium sheet still has to be proven in a very strong wind and some of the edge and lap anchorage details could be improved. It provides excellent run off and if it remains stable in all conditions it promises to be a very durable catchment.

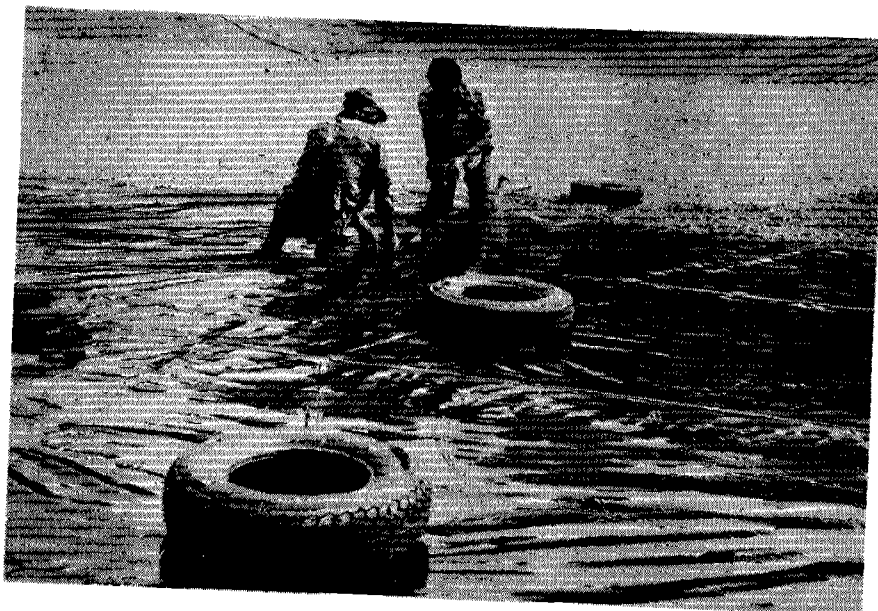
4. *Sealing a joint in the black polyethylene sheet. Note limestone aggregate covering in background.*

On relatively gentle slopes where polyethylene and limestone aggregate catchments can be used it is apparent that considerable savings in cost can be made over concrete catchments. So far there has been no sign of deterioration of the black polyethylene and it appears as though the thin layer of limestone aggregate gives it sufficient protection from the sunlight. The Polyethylene has the advantage of being a flexible sheet and should not require any maintenance. It should be remembered that this type of catchment is not 100% "efficient" and some increase in price should be made when comparing it with catchments of 100% efficiency.

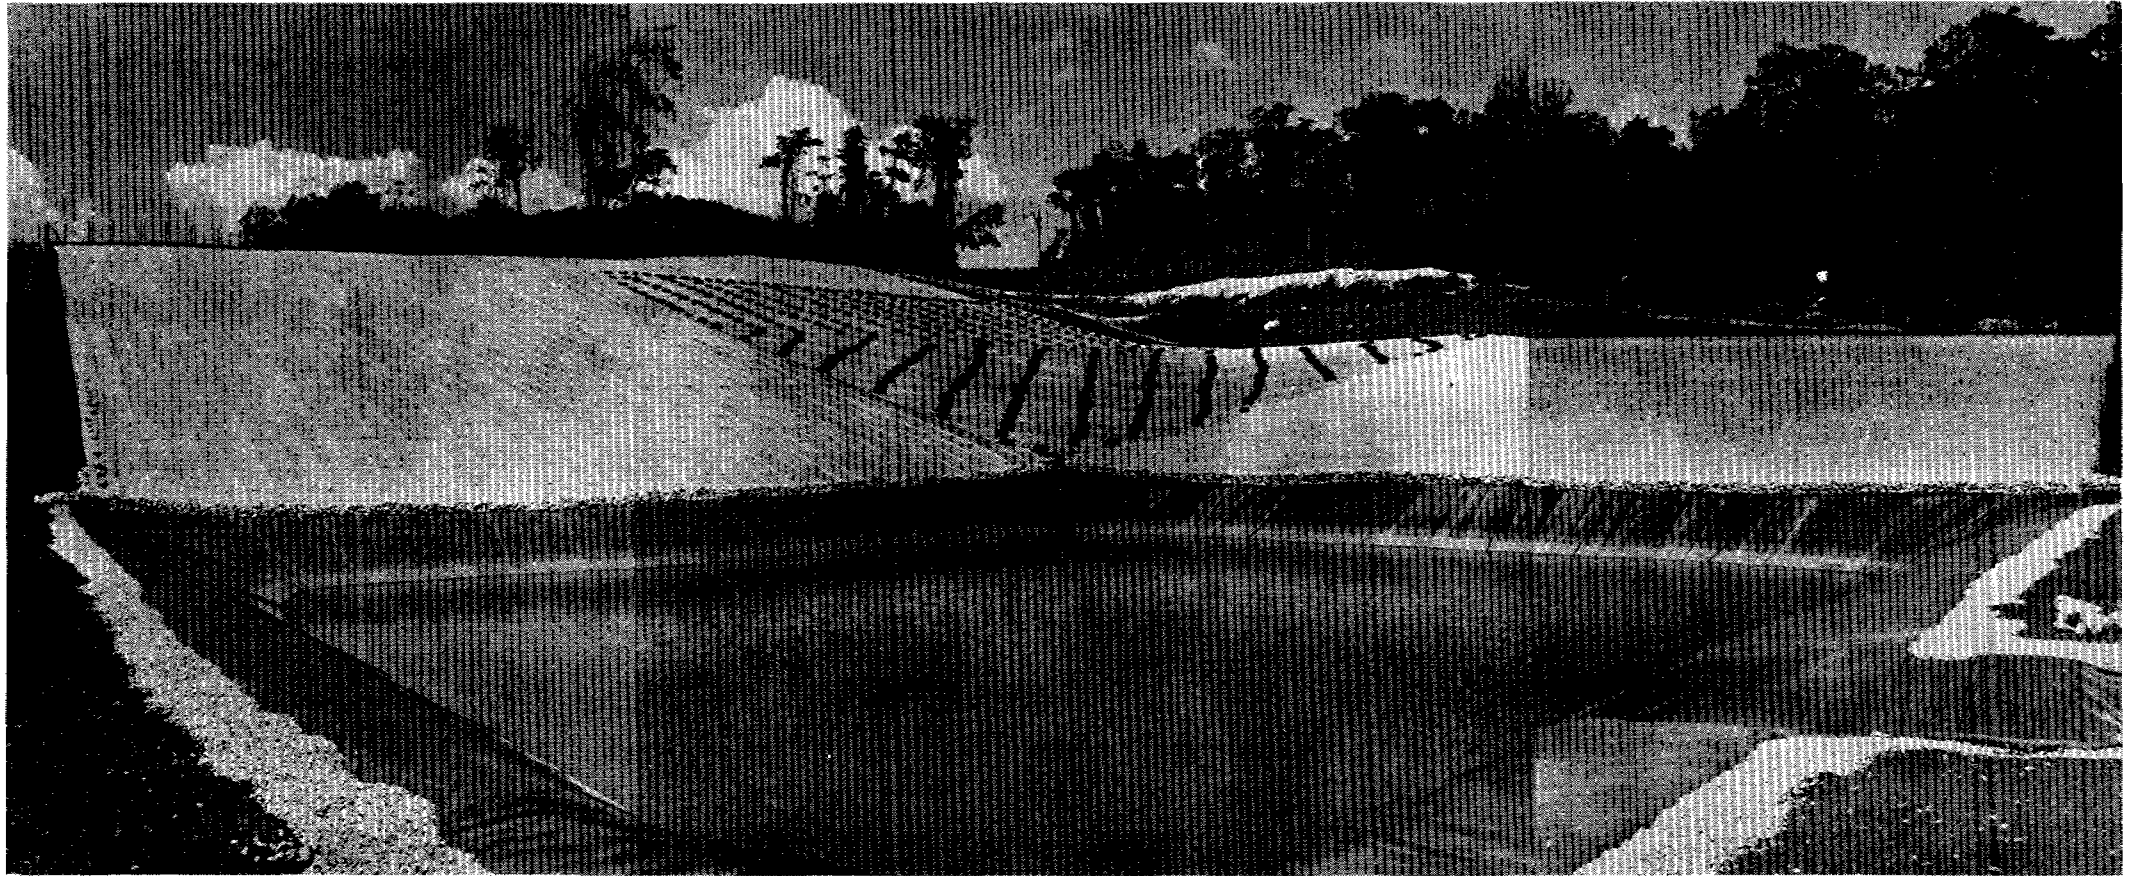
5. Completed WK.10 unit, July 1973.

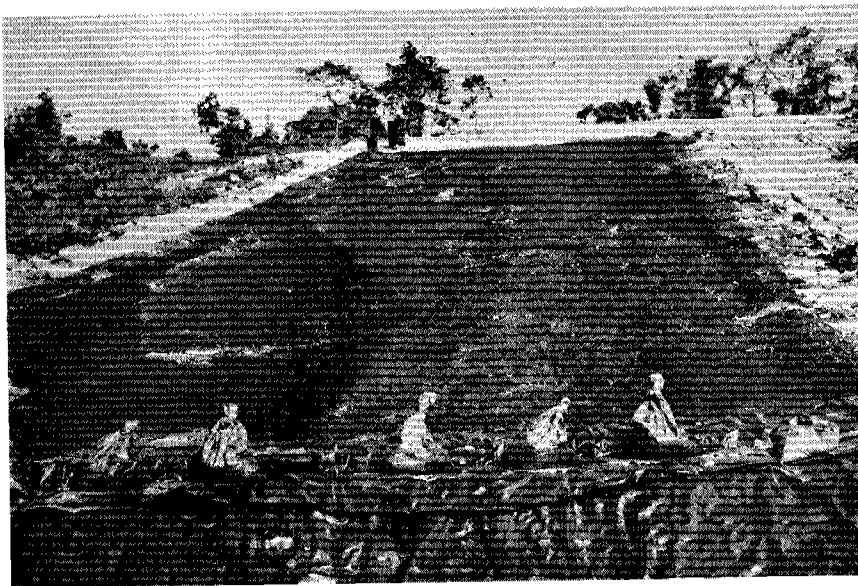
6. *Trial Catchment programme; bitumen reinforced with fibre glass.*

The liner to the pond serving the fibre glass reinforced catchment was replaced because the original liner had become covered with bitumen running off the catchment. However, after a short period of service it was apparent that the run off from the bitumen catchments was discoloured. For this reason no further interest was shown in the bitumen catchments in relation to the WK 10 unit. However, both catchments have performed well for the year they have been in operation. The fibre glass reinforcing made this type of catchment the most expensive of the trial catchments but the unreinforced bitumen catchment was the second cheapest trial catchment. The rough marl surface on which this catchment was laid will hasten its deterioration and it is evidently oxidising. All bitumen catchments are essentially shorter term installations which require a regular resurfacing. However the simplicity and speed of construction of this type of catchment may recommend itself to units that might be built for stock purposes only.

Reinforced bitumen membranes are at their most effective when the surface to be covered is cracked or small movements are expected. They are also recommended as pond liners.

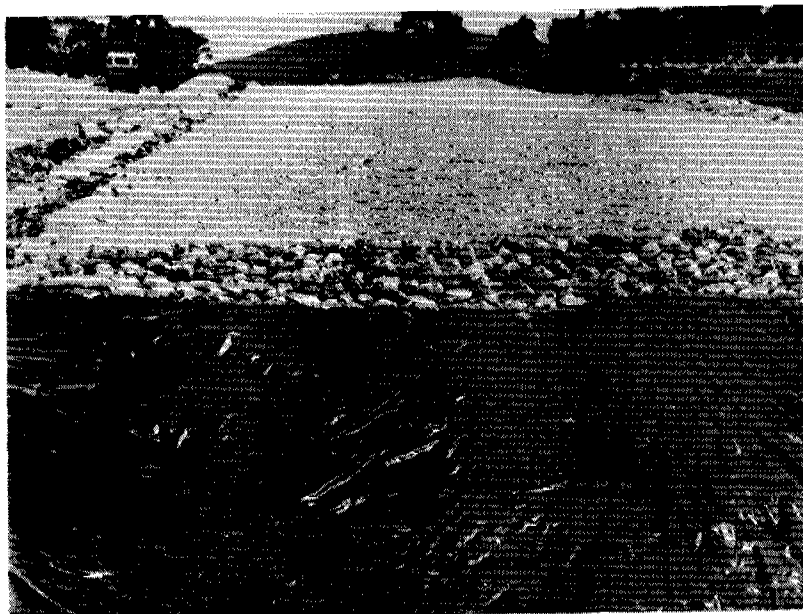
7. *Trial Catchment programme; polyethylene with limestone aggregate.*

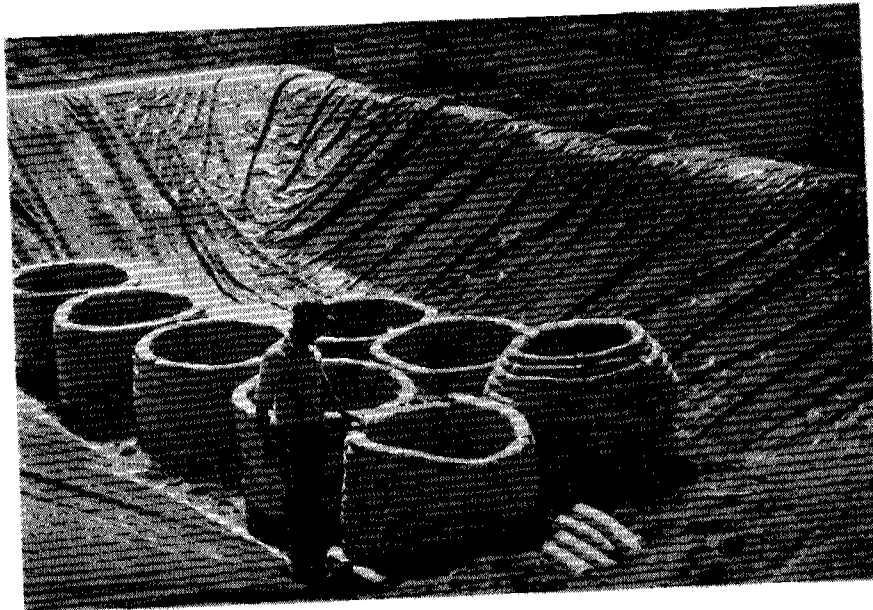
8. *Sand filter tank, trial catchment area; construction of beehives.*

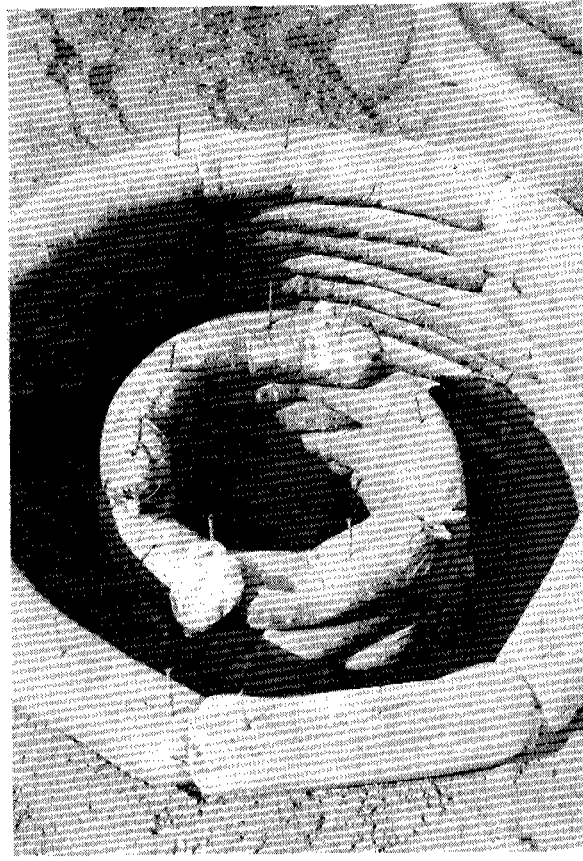
Sand filter tank, beehive with well shaft.

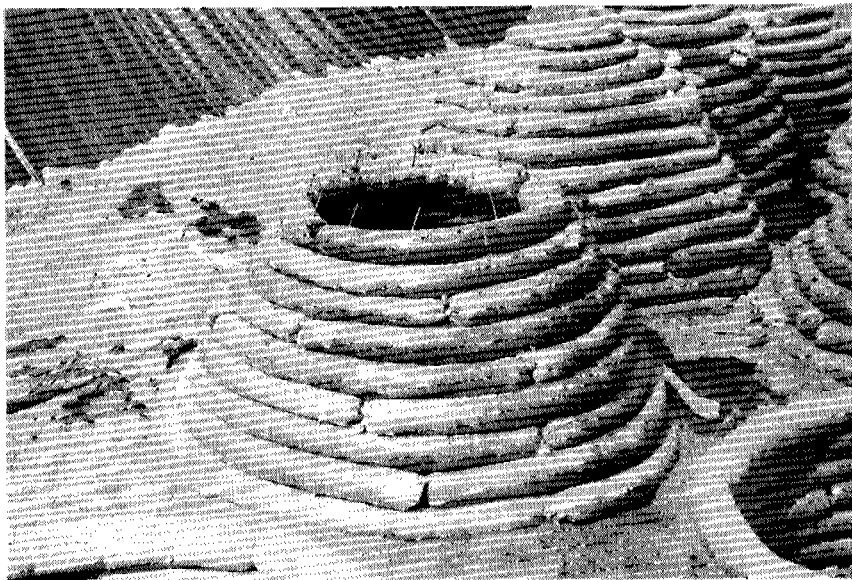
11. Sand filter tank; detail of dome structure.

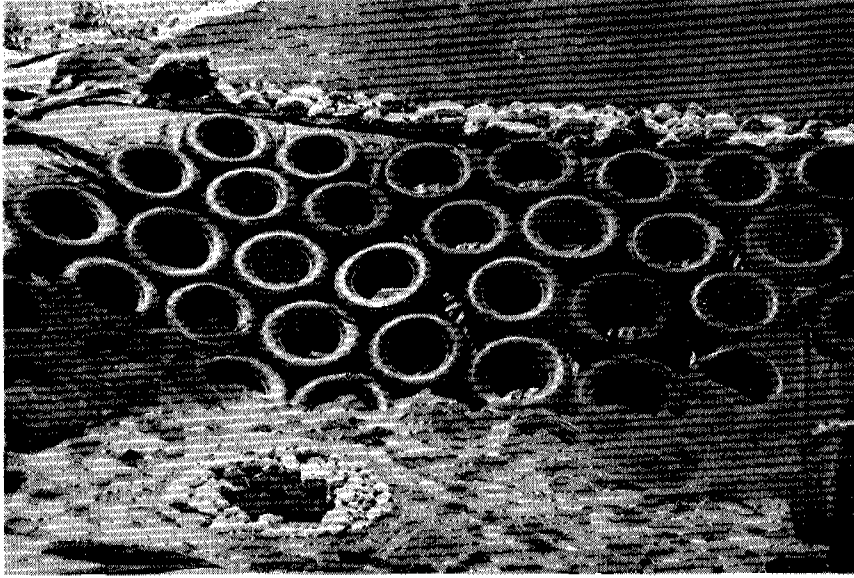
12. *Rock-filled tank; inlet face covered with tyres, sand layer in bed.*

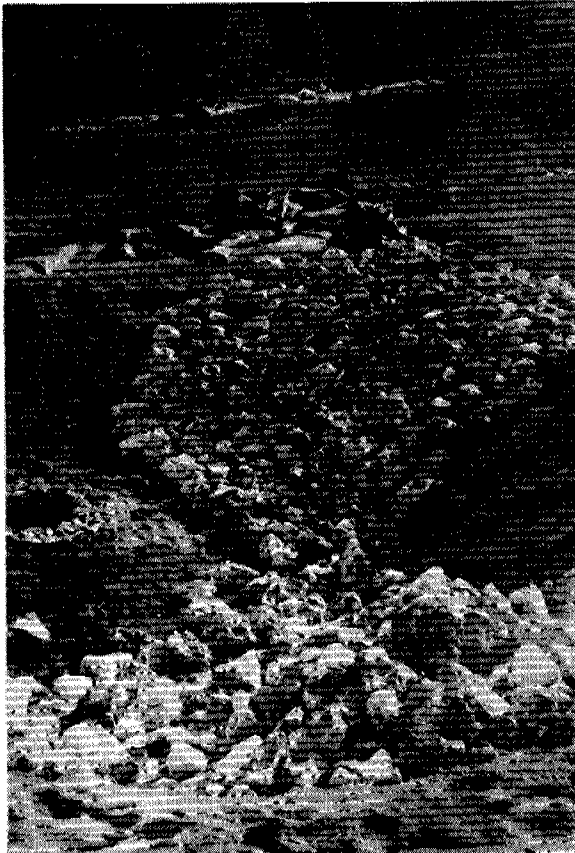
13. *Rock-filled tank; placing first layer of rock.*

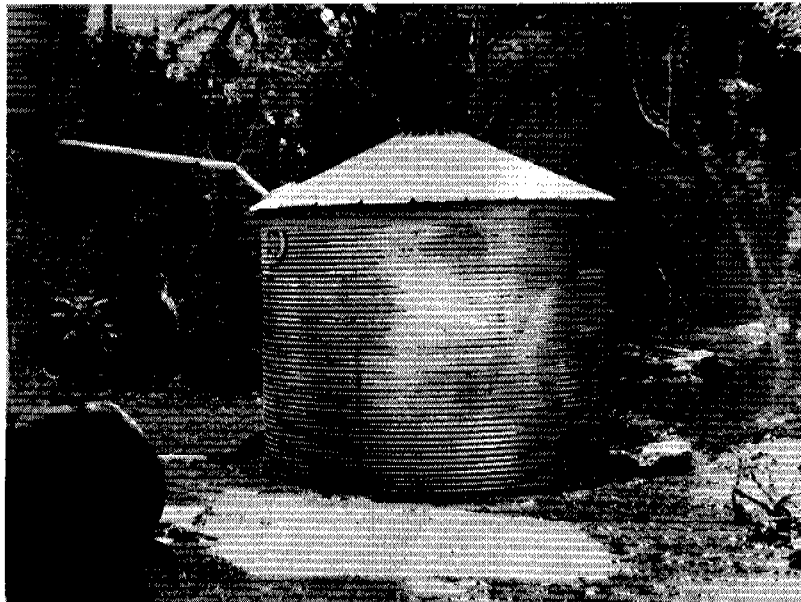
15. Completed 10,000 gallon PVC-lined tank at Cross Keys.

The 0.020in.thick PVC liner used in the Cross Keys tank has proved satisfactory. However this material is comparatively easily damaged and in the event of a large number of these tanks being erected by unskilled labour or by a trained team consideration should be given to the advantages of using a reinforced rubber liner. This material is heavier but would withstand greater punishment during construction than the PVC liner. In 1972 the cost of a reinforced butyl rubber liner was £81.00 FOB Great Britain compared to £38.50 for the 0.020 in thick PVC liner from the same supplier.
