# Catchment surveillance for water resource management

by Barry J. Lloyd and Teresa Thorpe

As water resources deteriorate and demand increases, should governments even attempt to manage and protect micro-catchments? A project in the eastern Caribbean concludes that they can and should — with a little help from state-of-the-art surveillance techniques, and practical grassroots action.

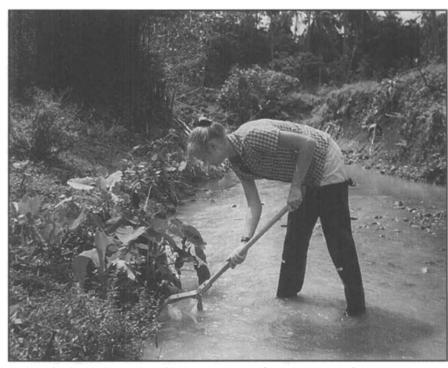
Taking biological samples of St Lucia streams for macroinvertebrates.

The importance of the biological monitoring approach is that it has the potential to measure the effects of the various major categories of pollutants, as well as human disturbance. It has demonstrated successfully—from programmes worldwide—that it can provide powerful evidence of their impact on the stream biota, and how this correlates clearly with water-treatment and supply problems.

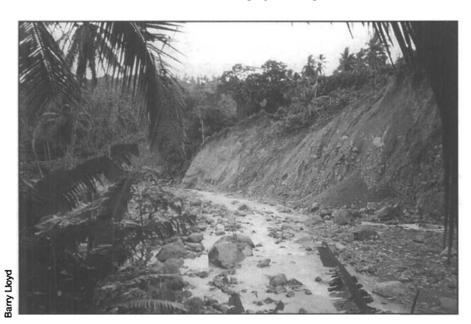
The Troumasse river, showing the loss of banana plantation, following heavy rains.

life. The tropical wave of 1996 demonstrated dramatically just what a waste of money this strategy was: in the space of 24 hours, large sections of the World Bank stream-bank strengthening works were washed away in some of the largest rivers, including the Fond d'Or, Troumassee, Roseau, and Cul de Sac. In the lowest reach of the Troumassee, the river actually reverted to an earlier route, by-passing the new civil works and washing away banana plantations on the edge of the river along a 5km reach where no buffer zone was in place.
