Water and sanitation in camps on the Andaman Islands

Jean-François Pinera and Bob Reed

When the Asian tsunami struck the Andaman Islands, nearly 7000 people were relocated in six camps. In spite of the large number of bathing and sanitation facilities built, water and sanitation conditions remained unsatisfactory in four of the camps. The facilities had been constructed without consulting their users.

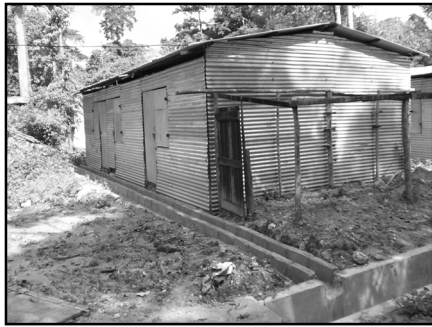
Shelters were built with corrugated steel sheets. Their size is about 20 m² for an average family of five. A total of 1962 shelters were built in camps ranging from 50 to 600 units.

A typical shelter for a family of five

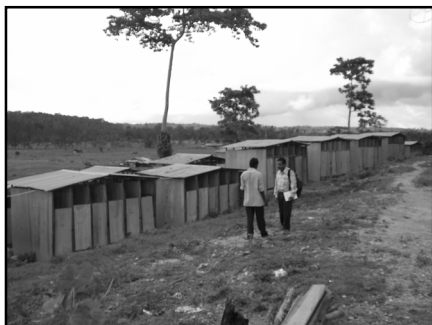
The toilet blocks were built away from the shelters

made of corrugated steel sheets. One to six sites were selected at the periphery of the camps for this purpose. In each of them, the number of cubicles varied from 50 to 100 toilets and bathrooms.

Toilet blocks were connected to septic tanks (usually one or two per site), wastewater being collected in above-ground PVC pipes and directed to the tanks, sometimes over relatively long distances.

This shows that when water is available and toilets or bathrooms are convenient and easy to access people use and maintain them. Improving access paths to toilets and bathrooms, implementing drainage works and ensuring that water is available on the spot would therefore contribute to increasing the number of facilities in use and maintained. It is a strategy that the NGO World Vision, who took over camp management in Little Andaman from October 2005, should follow. The organization intends to help to raise awareness about environmental health through hygiene promotion and will carry out the necessary improvement works. Another, even more fundamental improvement would be to implement a participatory approach of camp management, whereby committees with representation from the residents are created.

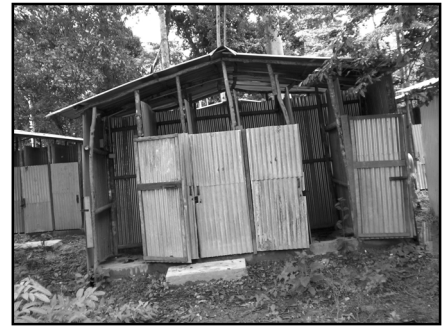
Unfortunately, these concerns had contradictory effects because people didn't like having to walk to large sanitary blocks where they found little privacy and in most cases no water and no light. Moreover, access paths were, in some cases, flooded or slippery. As a result, few of these blocks are in use. A large proportion of adults found it more acceptable to walk the same distance, but to the forest. Children were often seen defecating in corners of the camps. A majority of camp residents had no toilets in their original homes and were used to open defecation on the beach. In their new home, there was no beach where they could go (except for fishermen) but using toilets in these conditions was not an option attractive enough to make them modify their habits.

These toilets had been abandoned

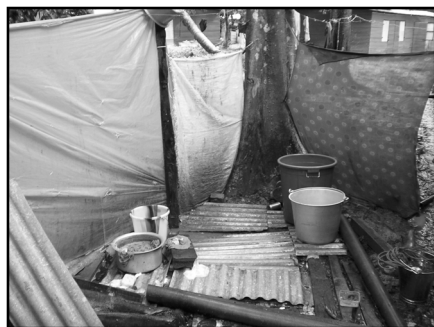
The bathing cubicles provided were replaced by improvised bathrooms built in front of many of the shelters. These bathrooms sometimes created an accumulation of stagnant water.

An improvised washing area

Recent feedback from the NGO suggests that works on drainage and water access are ongoing. One of their main projects is the installation of rainwater harvesting systems wherever possible. The creation of camp management committees is also ongoing.
