Costing water services in refugee camps

Camp Bambasi, Ethiopia, and Camp
Kounoungou, Chad

Christelle Pezon, Kristof Bostoën, Mélanie Carrasco and Ruzica Jacimovic

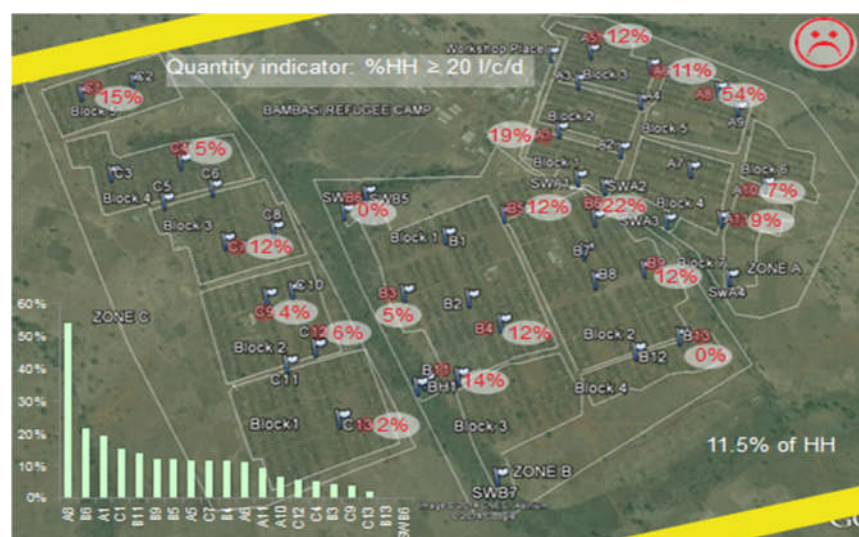
Figure 3 Tap stands and percentages of households receiving above-standard service

Results of the water point survey differed substantially from the WASHCard data. The average quantity of water collected was below 10 litres per capita per day. Only 11.5% of the sampled households collected more than 20 litres per capita per day (Figure 3), and 67% households scored a critical level of service (less than 10 litres per capita per day) (Figure 4).

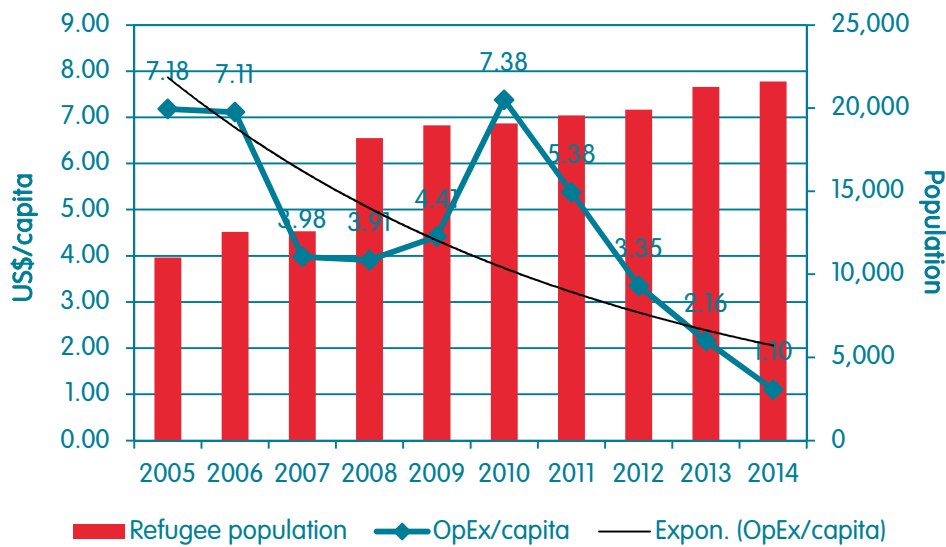
Figure 15 Reported operational expenditures per capita, 2005–2014

OpEx per capita, based on the camp's registered population, decreases as the number of users increases, though in 2010 it rose to \$7.38 per capita (Figure 15). Operational expenditures were for the pipe scheme and hand pumps in 2011, and for all three systems starting in 2012. However, there was no OpEx on the solar system in 2013 and 2014, and nothing was budgeted for hand pumps for 2014. Thus the OpEx per capita figures are based mostly on operation of the pipe scheme.

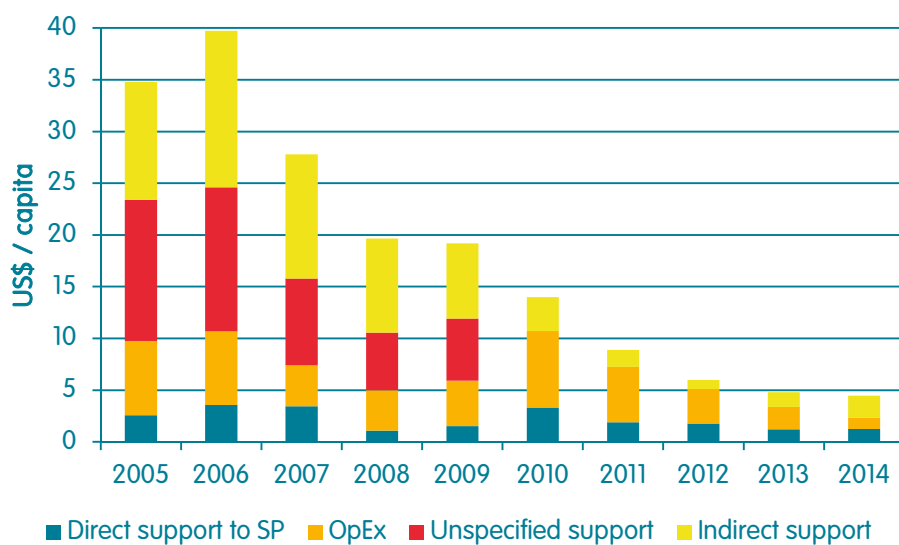
Figure 18 Recurrent expenditures per capita, 2005–2014

More was spent on management costs (unspecified direct support and indirect support) than on systems (OpEx and direct support to the service provider) from 2005 to 2009 (Figure 18). OpEx has been the largest component since 2010, although decreasing year after year. In 2014, budgeted OpEx was slightly less than indirect support and support to the service provider.
