Water Supply pumps Project

Laboratory Testing,
Field Trials
and Technological
Development

Report No. 1
March 1982

UNDP/WORLD BANK - RURAL WATER
SUPPLY HANDPUMPS PROGRAMME

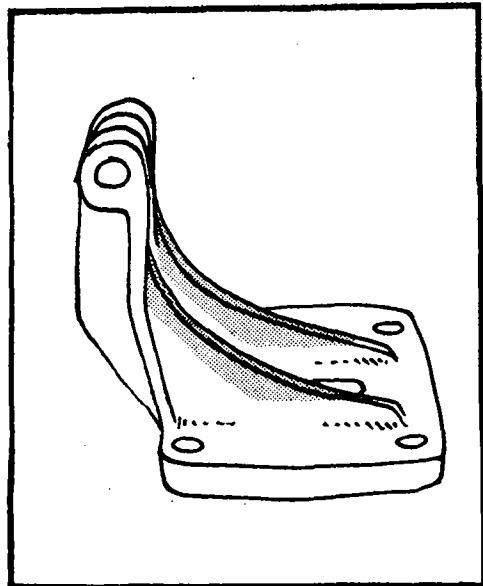
The handles of both pumps, and a third spare handle, were broken in transit, and the cylinder top casting of one pump was cracked.

2. The webs on the cylinder top casting should be extended (see sketch, right).

3. The handle should be more robustly designed or made in a more resilient material (such as wood).

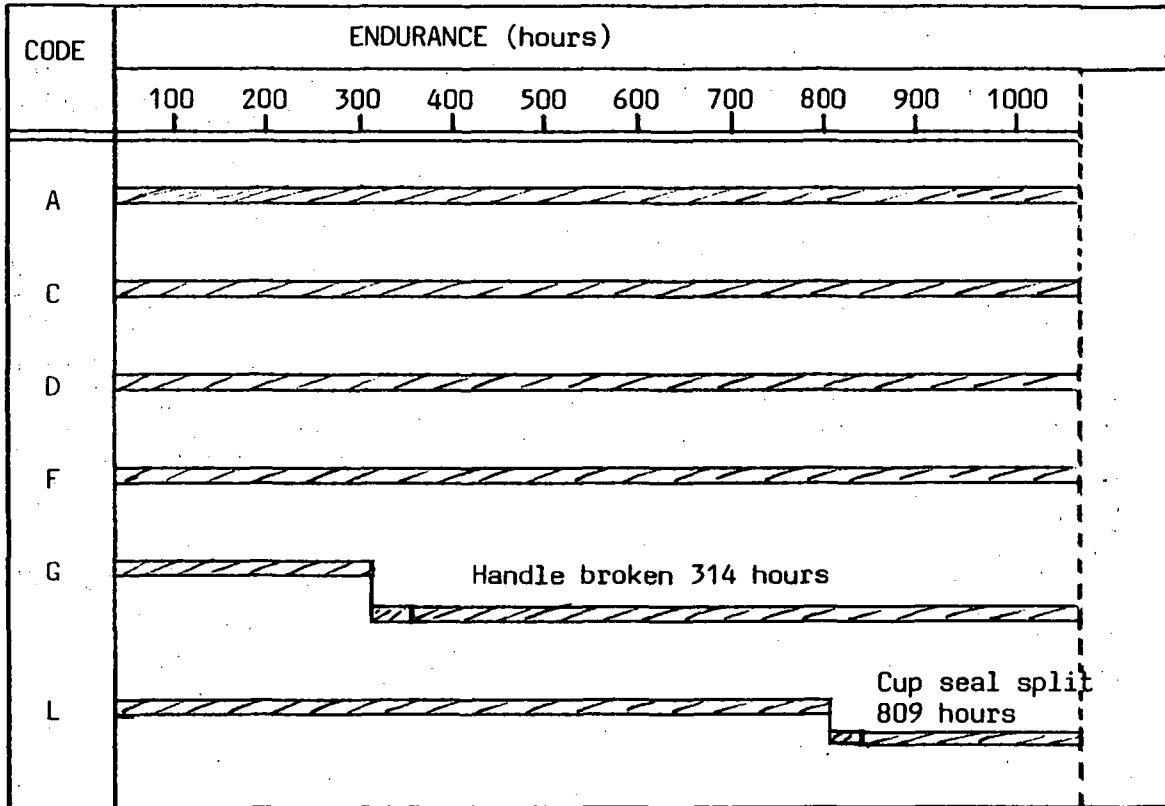
TABLE 19 : Endurance Testing

There were two pump failures within the 1st 1000 hours of endurance testing for Batch 1:

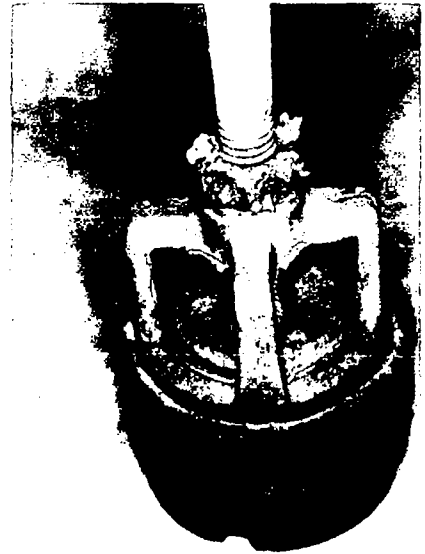
- CODE A
1. A nut had become detached from the upper of the two foot valves and was lodged in the lower. It was refitted.
 2. The rubber seat on the lower foot valve was noticeably worn but nevertheless appeared still to be in working order. It was not replaced.
 3. The head of the piston valve was noticeably worn on its diameter but appeared still to be in working order. It was not replaced.
 4. No significant corrosion was seen on any brass or gunmetal component, but the connecting rod lock nut, of zinc-coated steel, had a heavy corrosive deposit. It abuts the cast gunmetal piston body.

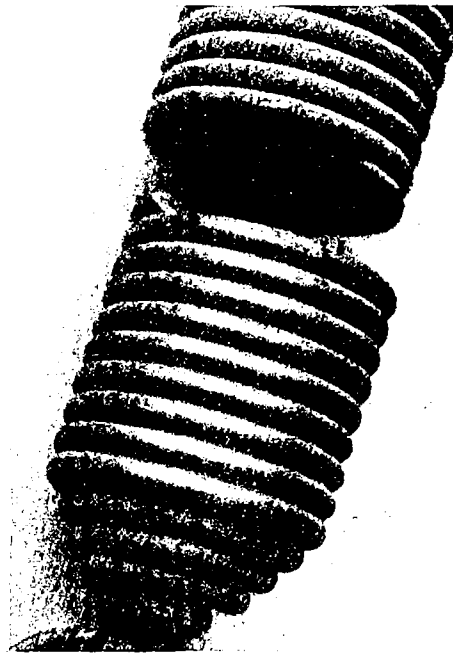
CODE D 1. The return spring wa found to be broken (right).
This would account f the "knocking" heard during testing.
The spring was replaced.

2. No significant corrosion.

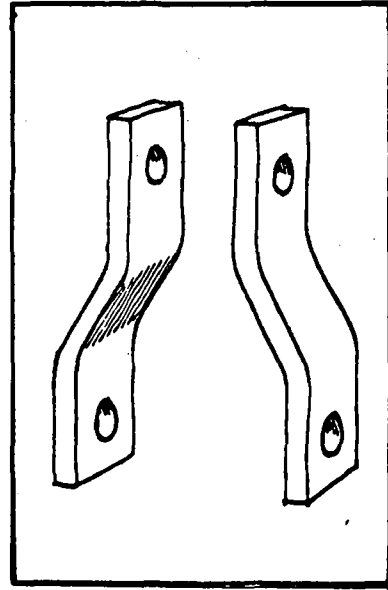
2. The wishbone link may be better as two joggled steel strips (right).
The handle fulcrum pinch bolt as located at present, forms a finger trap.

The pinch bolt should be moved 90° to the underside, or replaced by two circlips on the shaft, similar to those on the wishbone link pivots.

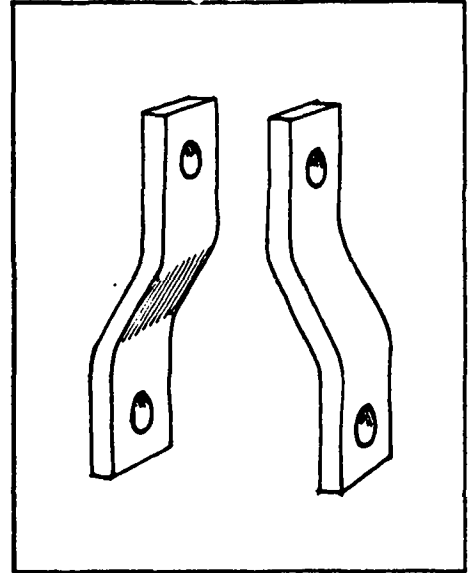
2. The wishbone link may be better as two joggled steel strips (right).
The handle fulcrum pinch bolt, as located at present, forms a finger trap.

The pinch bolt should be moved 90° to the underside, or replaced by two circlips on the shaft, similar to those on the wishbone link pivots.

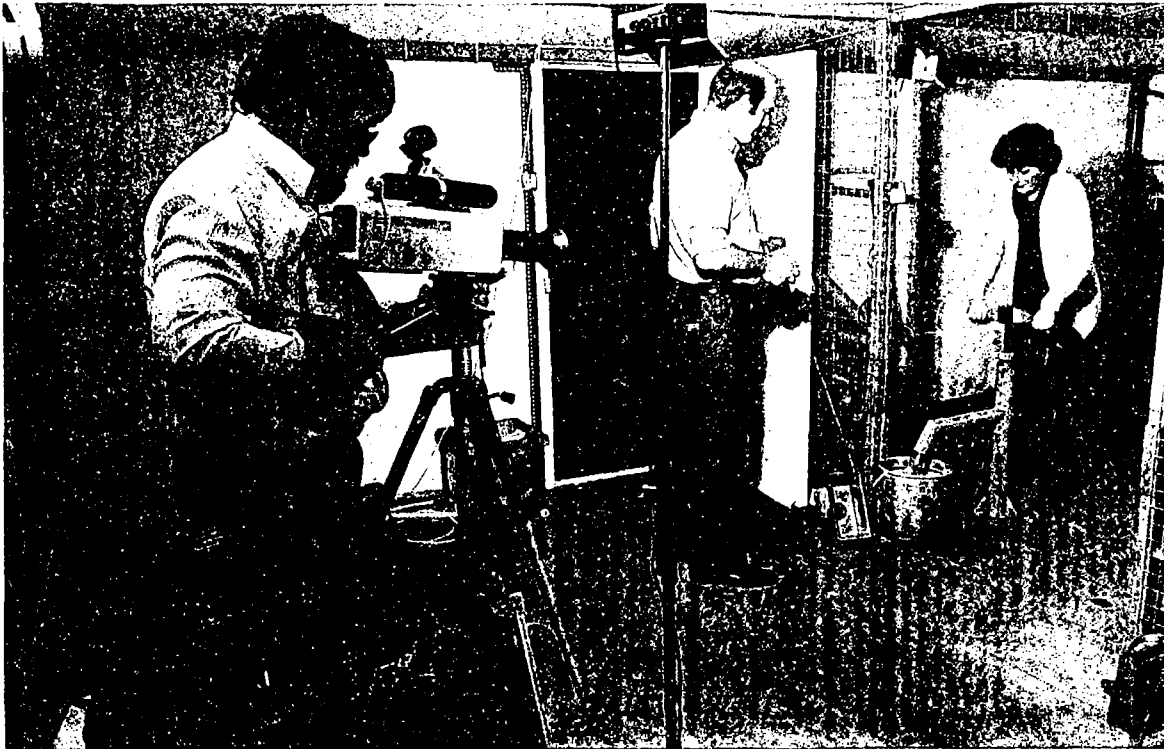
5.3 OBSERVATIONS

Observations of the users in the Batch 2 trial were reinforced by selective video recordings.

CODE B Many users found it difficult to decide on the best method of operation for this pump. The arc of handle movement is particularly large, 178° for a full stroke. In spite of this, some users chose a full stroke but found the exaggerated body movements uncomfortable.

- CODE H Many users found this pump difficult, especially short children. Most of the effort had to be supplied by the arms and shoulders only. Several smaller children found the handle difficult to lift, and changed their grip between up- and down-strokes. Some could lift the handle only by sliding their forearms beneath it until it rested in the crook of their elbows, then arching their backs. This was a very awkward movement and resulted in very short strokes. Users with such difficulties tended to make matters worse by pulling unevenly on the two sides of the handle, increasing the friction in the bush at the top of the pumpstand.

- CODE J A difficult pump to use. Users with enough strength and bodyweight could attain sufficient momentum to keep the handle turning smoothly. Most could not, and found it difficult to 'time' their efforts on the handle. Several children could not operate the pump at all. However, it should be noted that this pump lends itself to operation by two people.

- CODE K This pump is similar to Code B, and users had similar problems. An additional difficulty arose because vigorous operation of the pump often caused the outlet diverter valve to drop, shutting off the spout. See Purple Alert, Appendix III.
