# STATUS OF THE AID TYPE HANDPUMP IN THE DOMINICAN REPUBLIC

WASH FIELD REPORT NO. 98

AUGUST 1983

Prepared for:  
USAID Mission to the Dominican Republic  
Order of Technical Direction No. 143

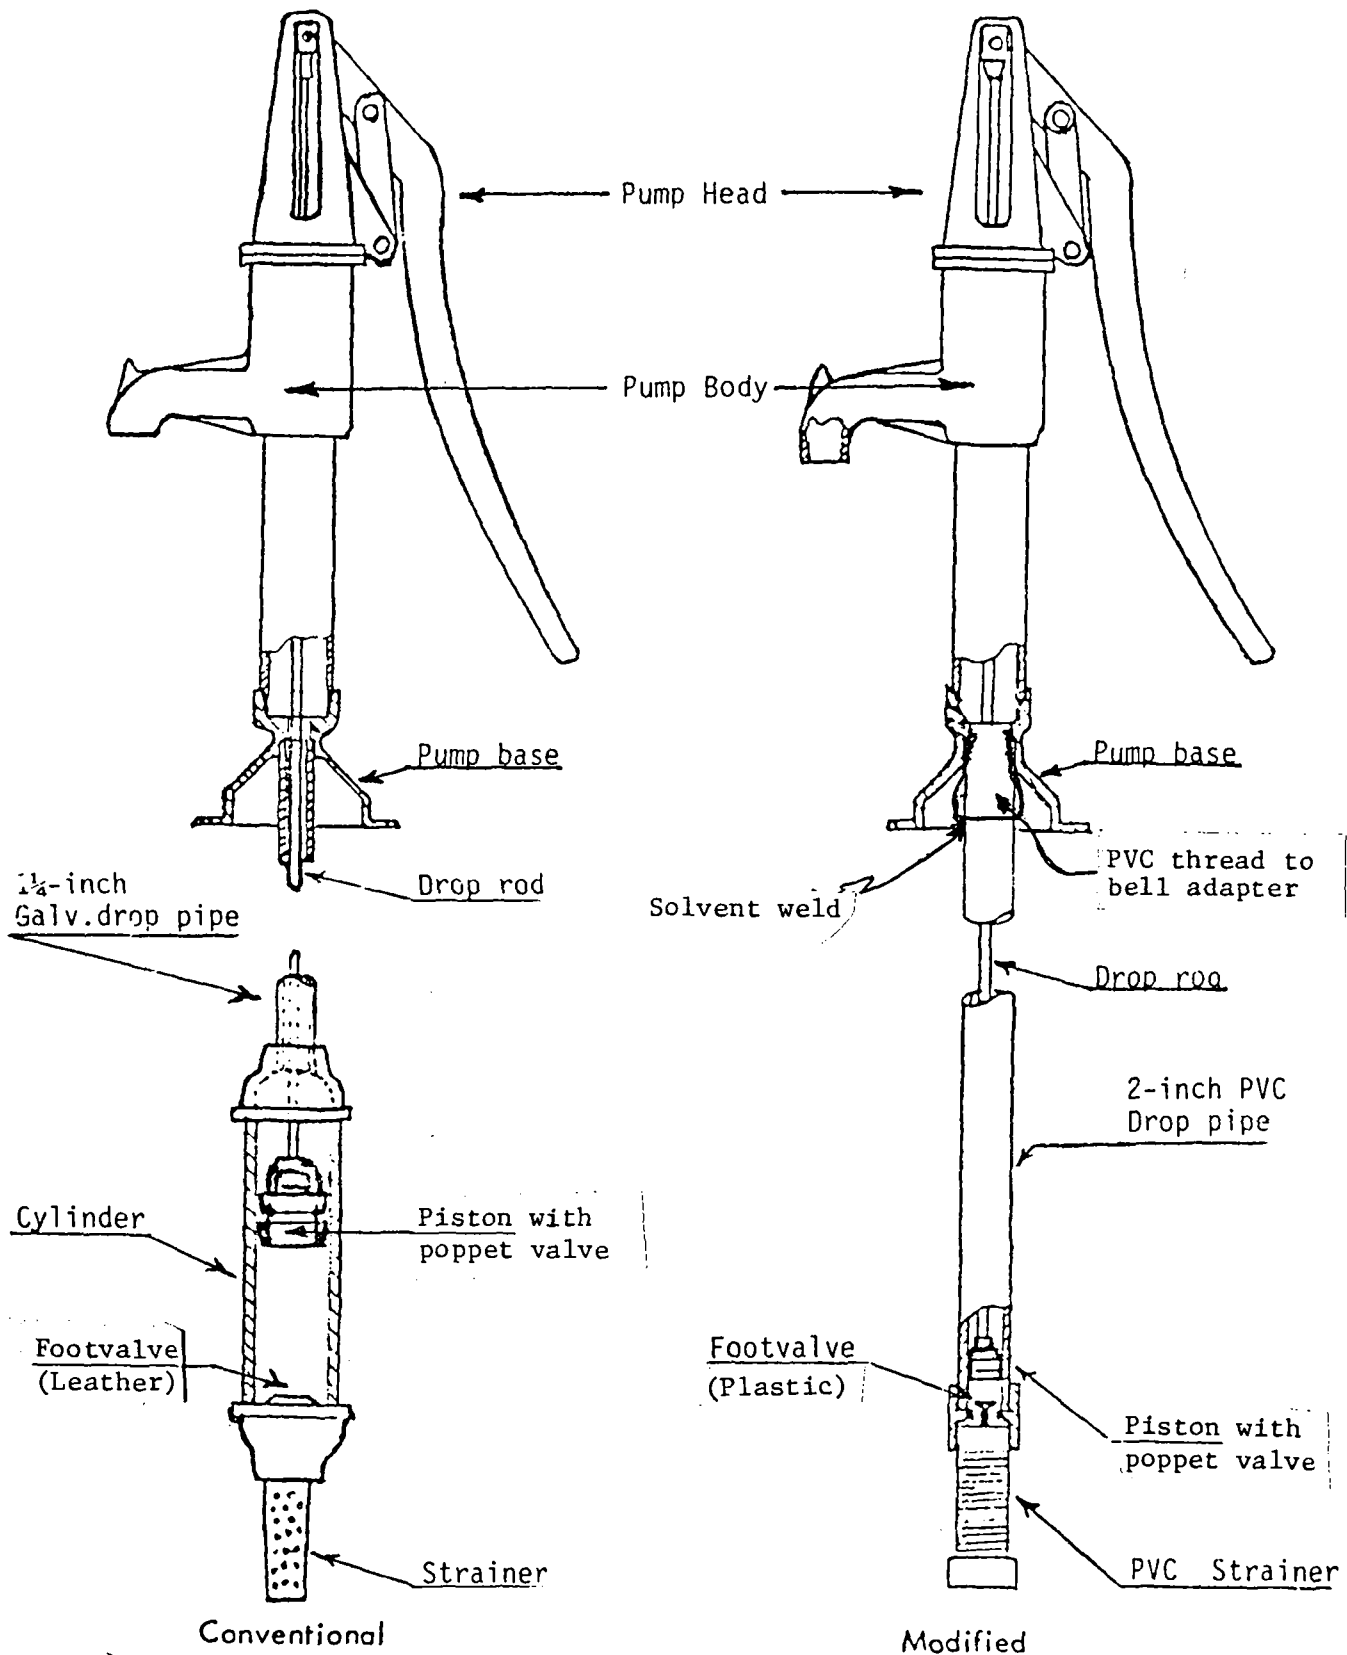
Figure 1

In January 1983 a technical/management review team visited the Dominican Republic to look at its AID handpump program and found evidence that the program was experiencing problems with a modified version of the AID handpump that featured a 2-inch PVC drop pipe and a PVC foot valve. The modified pump differs from the conventional AID-design handpump in that the conventional one uses a 1.25-inch galvanized steel drop pipe and a 3-inch cylinder (see Figure 1). A substantial percentage of the pumps were failing to operate properly just a few weeks after installation. The review team suggested a field investigation be conducted to determine the cause of failure of the modified pump. Based on this investigation a corrective course of action could be recommended.
