REPORT ON TRIAL
OF WAVIN HANDPUMP IN INDONESIA

PREPARED BY
DIRECTORATE OF WATER SANITATION
MINISTRY OF HEALTH
GOVERNMENT OF INDONESIA

UNITED NATIONS CHILDREN'S FUND (UNICEF), JAKARTA, INDONESIA

September 1988

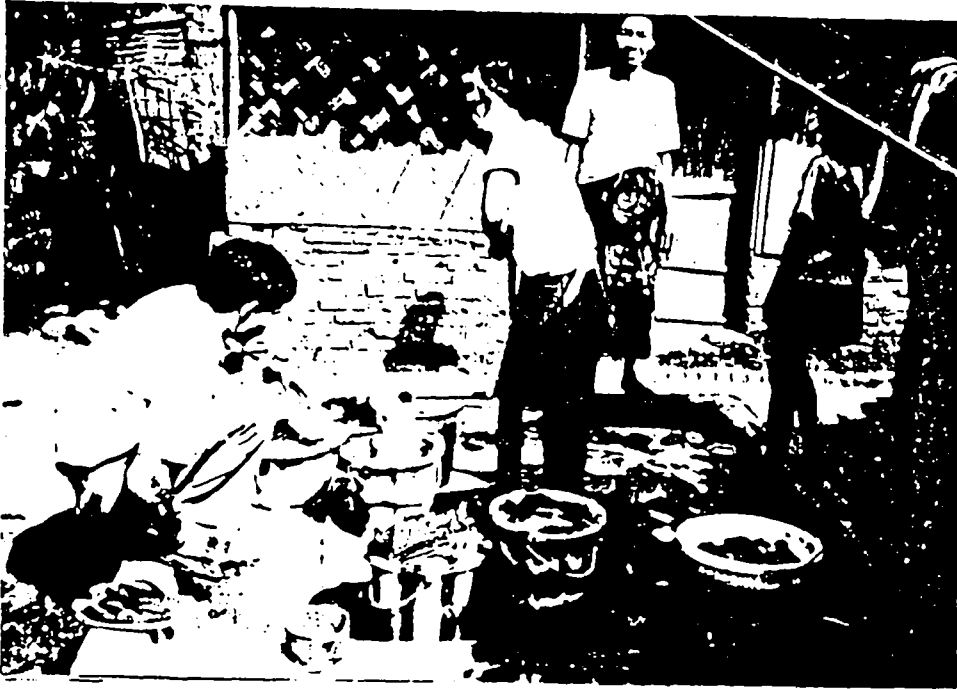
20 wavin handpumps installed in 3 villages, were found to be working continuously with no breakdowns in the last 8 months of operation. Communities developed faith on the reliability and efficiency of these pumps.

Within few days of installation of each pump, communities started to appreciate the large continuous volume of water discharged for both upward and downward movement of the handle and the less energy they had to spend to fill their bucket. They soon adapted to the new pumping stroke and found it efficient and easy to operate.

Light weight and simple design, allows the pump to be dismantled and rolled back in less than 30 minutes by two persons. The only tool required is a screw driver. Communities have replaced plunger seals, adjusted cylinder piston depths by themselves. So far, meantime between the breakdowns is found to be practically zero.
