A study of hafir linings in Darfur Province, Western Sudan

Report No OD/10

August 1977

Hydraulics Research Station
Wallingford
England

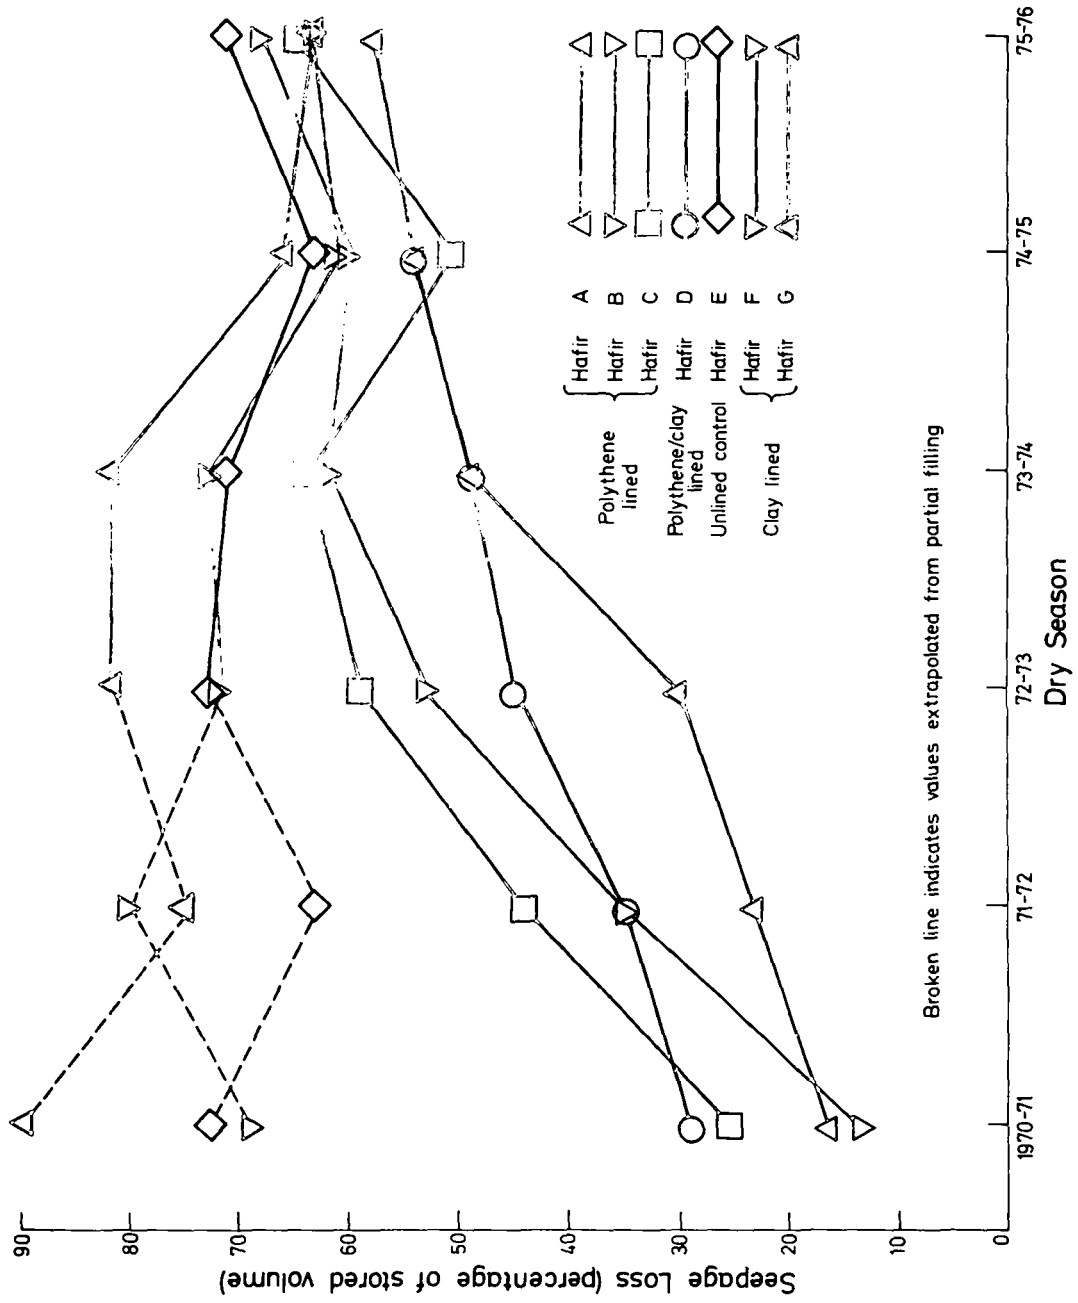
Fig. 5

- 5.2.1 The results are given in Table 8. They are also plotted in Fig 5 in which the values for hafira A, B and C are shown in green. (Hafir D is included in the clay-lined group since the polythene was intended to stop the clay from drying and not act as the waterproof membrane).

Comparison of Seepage Losses

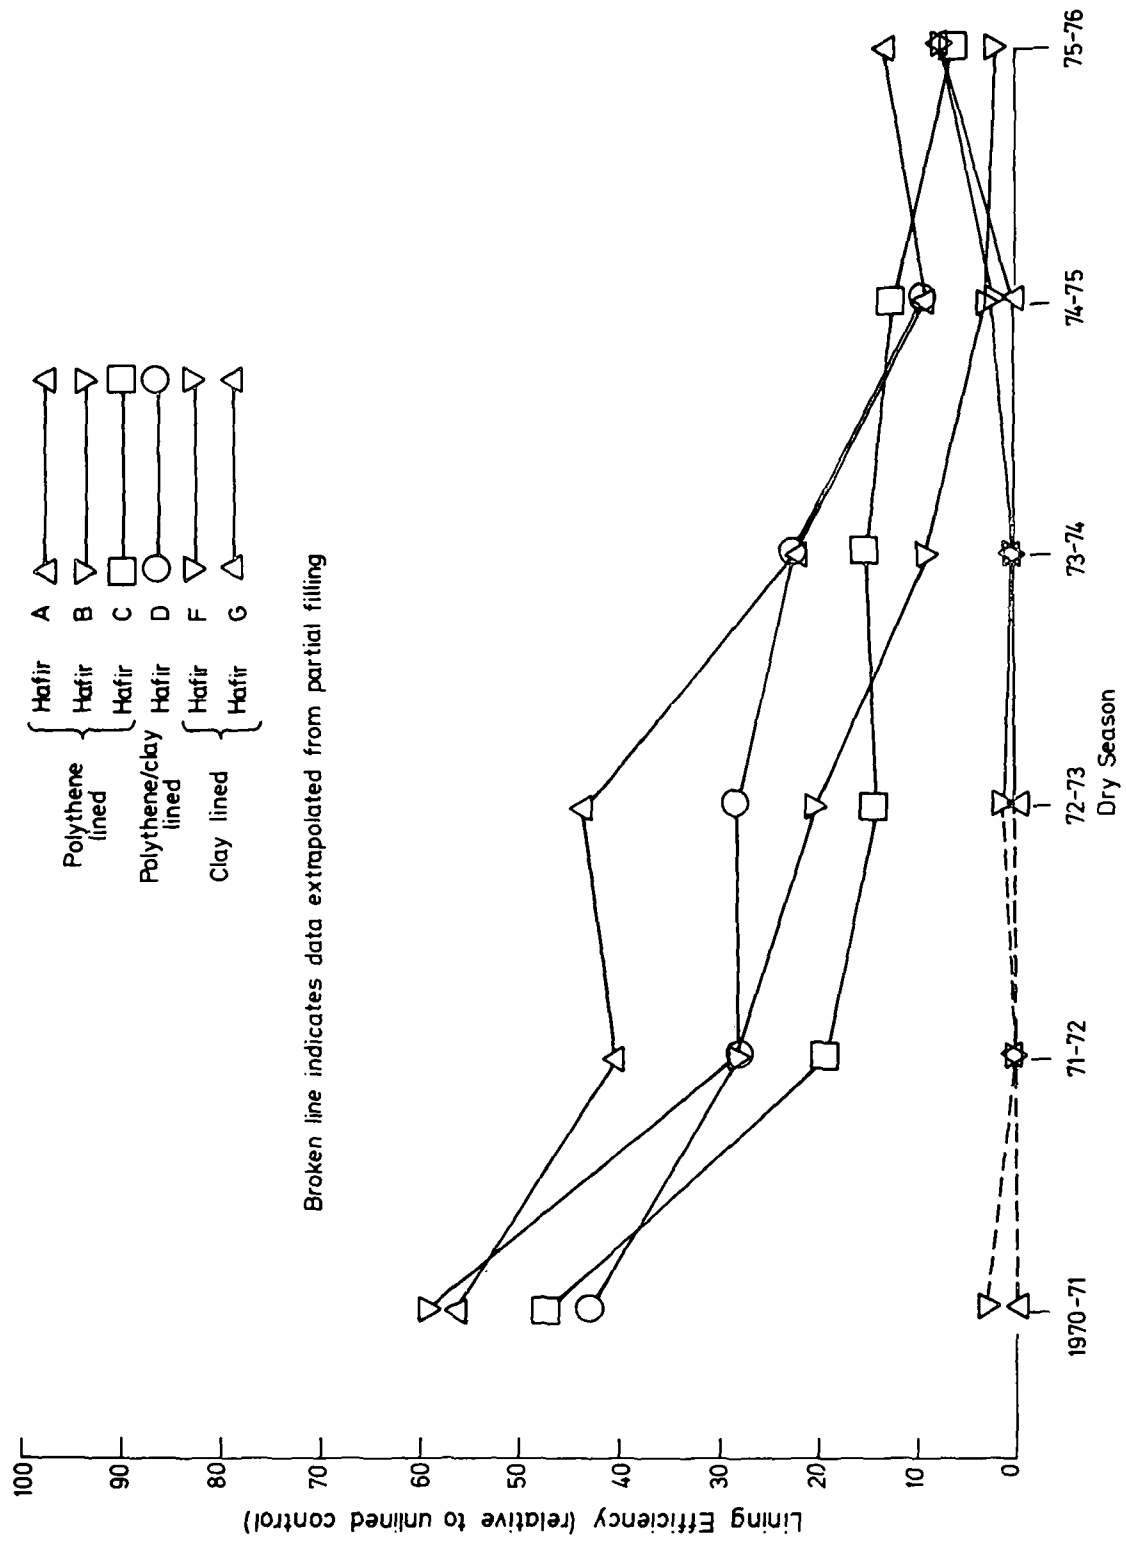
Fig.6

- 8.1.1 Figure 6 shows that the clay linings of hafira F and G did not significantly control seepage at any time. This is thought to be mainly due to incomplete compaction of the clay during construction. Soil compaction is normally controlled by reference to a standard laboratory test such as Procter. These procedures do not appear to have been followed with a significant degree of precision at Lunya for various practical reasons. There remains little doubt that the initial state of the clay linings was seriously impaired as a result. Prior to the 1974 wet season the conductivity of the thick clay lining (hafir F) exceeded 0.004 m/day compared with a properly compacted value of about 0.00005 m/day. For the thin clay (hafir G) the value exceeded 0.008 m/day. This is further evidence that compaction was undeveloped in the clay layers, a construction fault which dominated their subsequent performances.

Comparison of Lining Efficiencies
